Major Electrical Issue

May 24, 9007

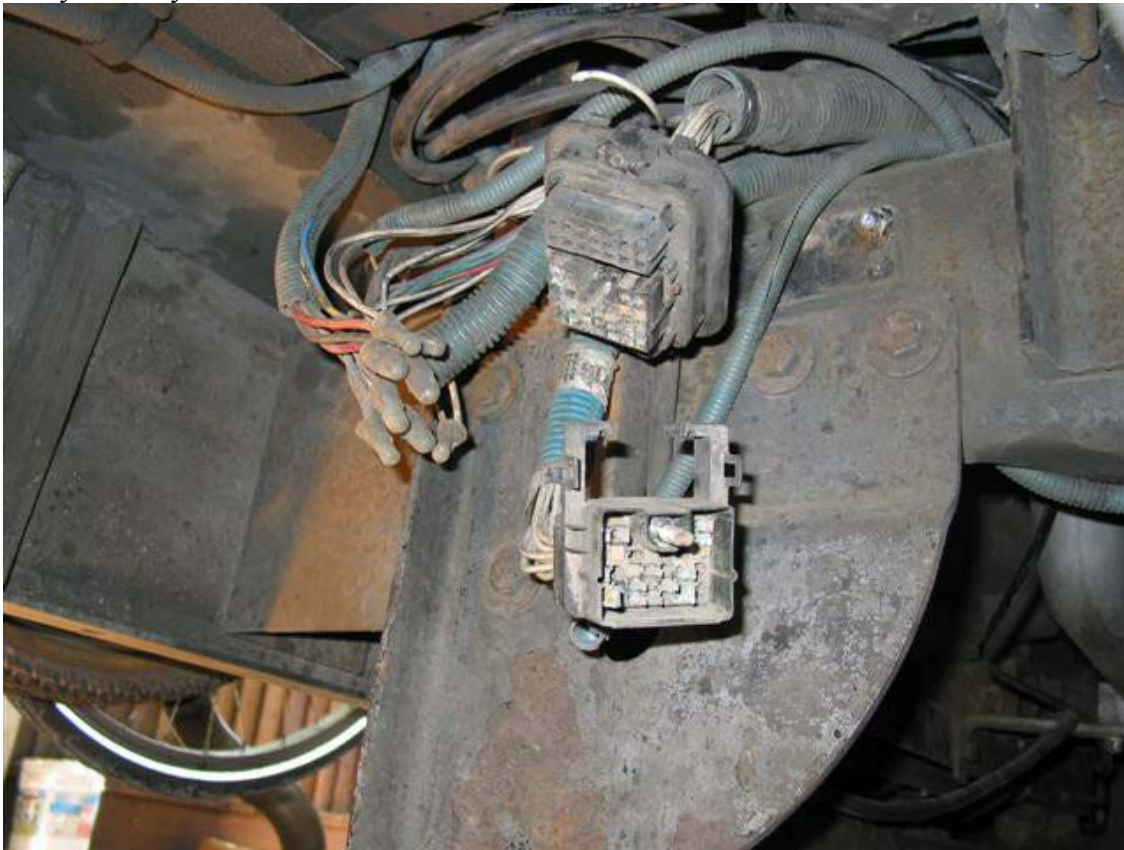
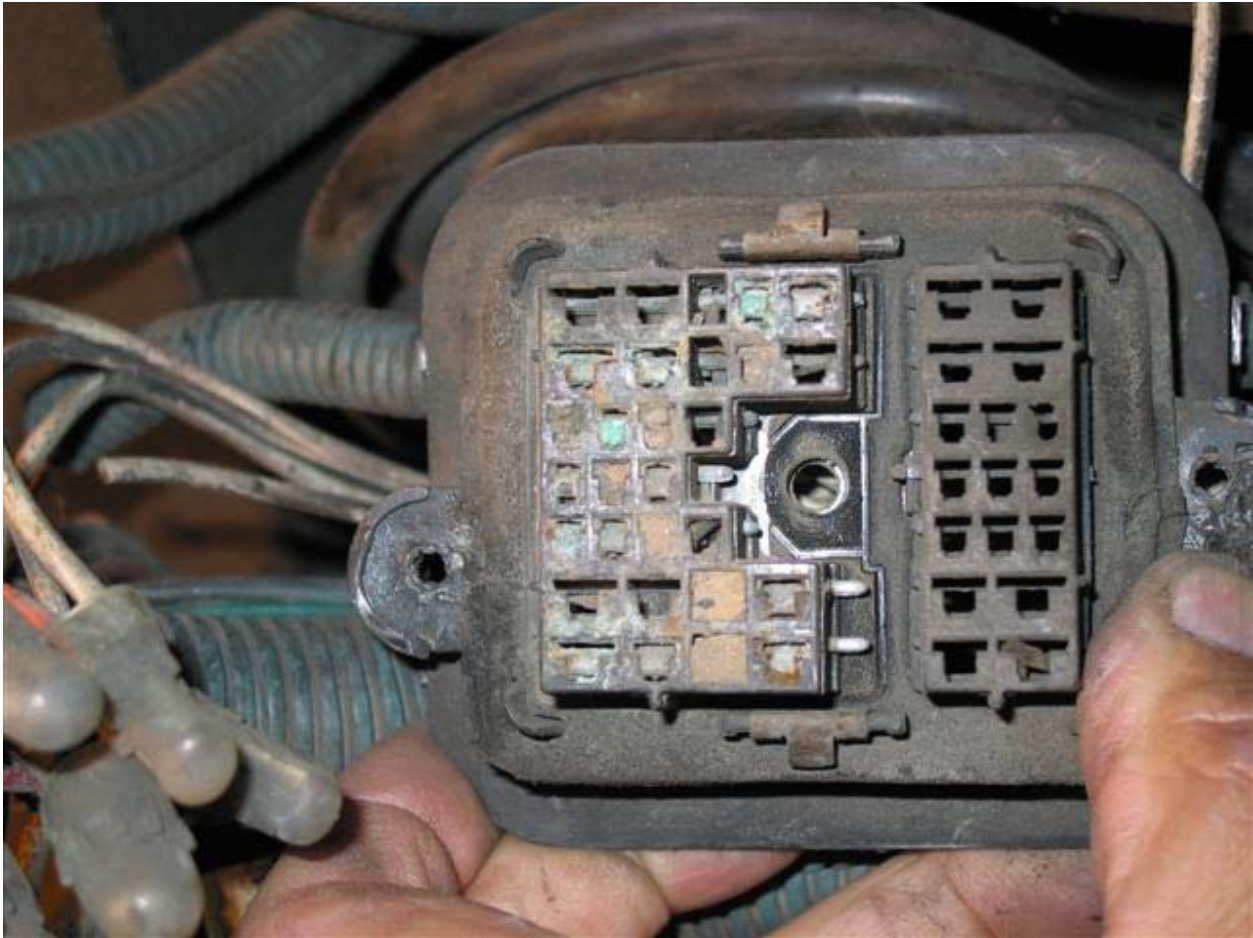
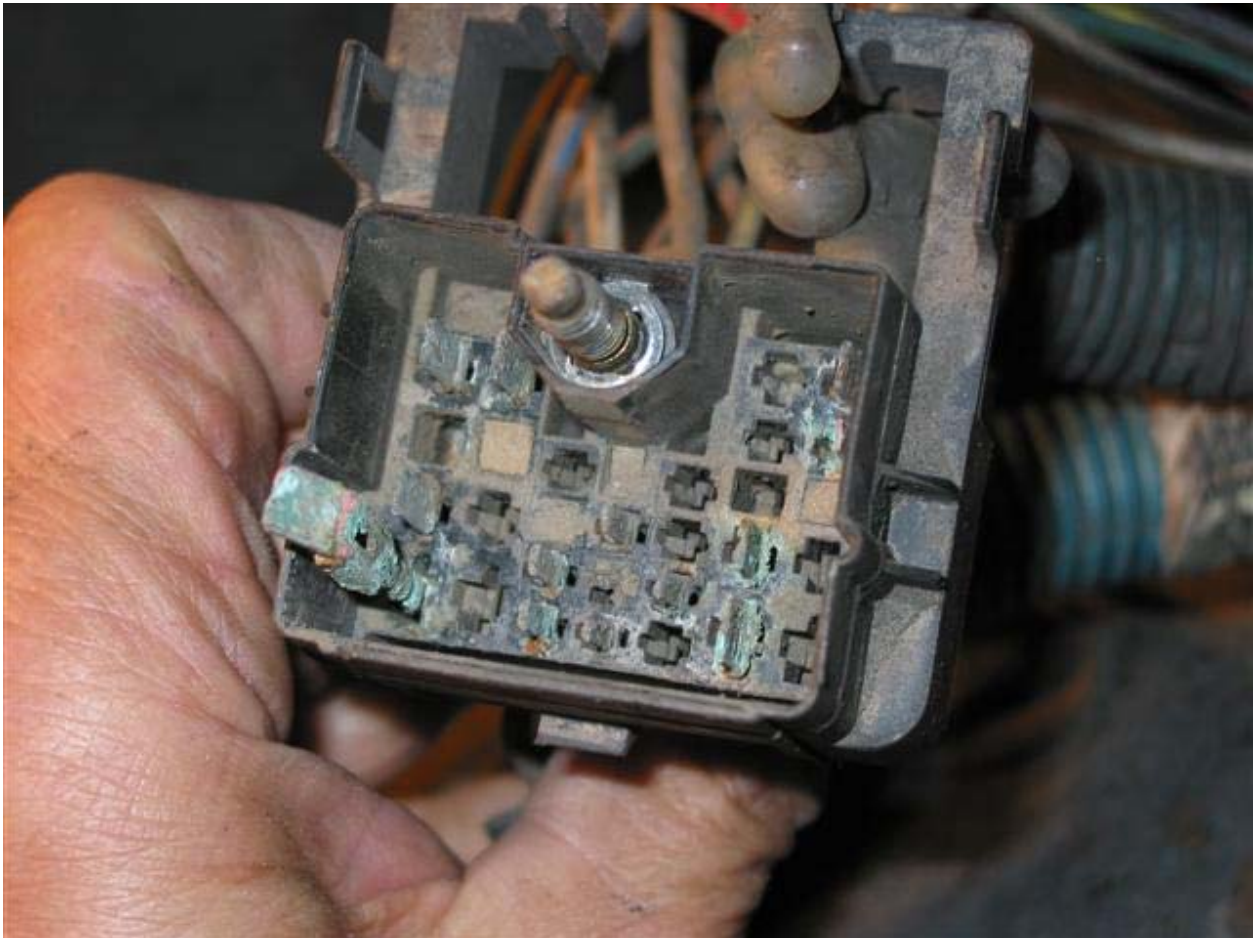
Viola! Signals were present on the coach side but not on the chassis side. (I have a very sharp pointed test lead that pierces the insulation) I started to separate the connector halves and that is when I lost a lot of religion!! Two wires broke off with almost no force, when the connector halves separated, one blade of the connector pulled right thru! Everything and everywhere was corroded! I do not know how anything even worked! I had noticed some fluctuation in the oil pressure and temperature gauges but seemed to be linked more to the gauge connection, or so I thought at the time.

Are you ready for this?

That was on Wednesday morning. I started to examine my options and decided to eliminate the connectors entirely as I was never planning to separate the coach body from the chassis and that would permanently fix any of these issues in the future.

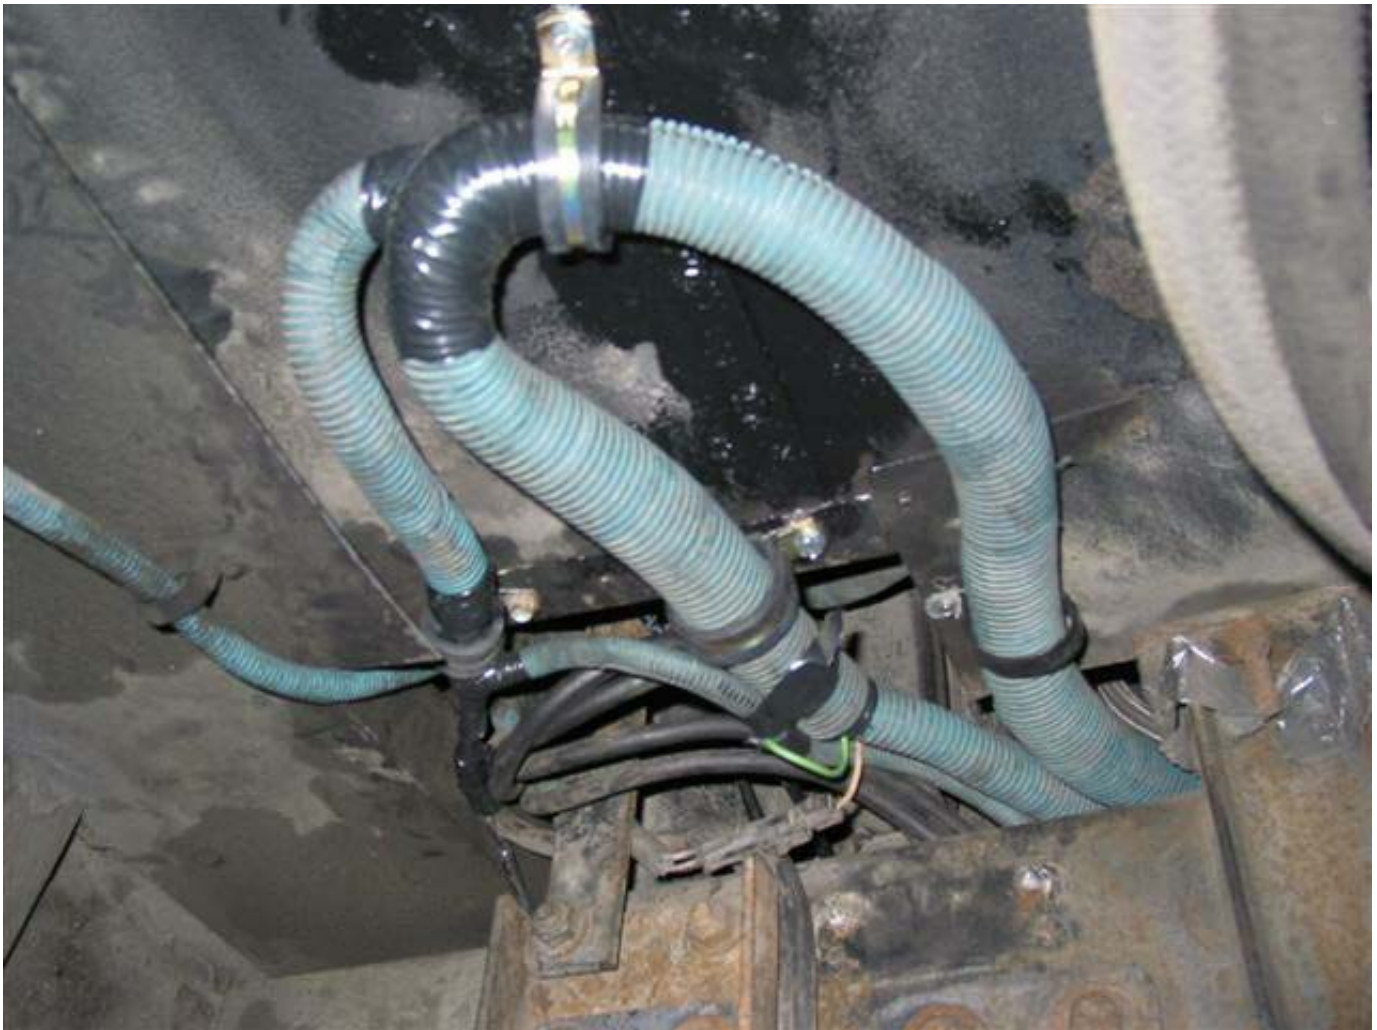
I decided to eliminate the extra length of each cable and redress the cable routing in that area. I have been doing this sort of upgrade whenever I tackle a repair, I redesign or clean it up, will be no different. Late this afternoon, this is what the new cable looks like in the area where the connectors were.

All wires were cut, shortened, inline twisted and soldered, and covered with two layers of shrink tubing. The connections were staggered so there would not be a BIG bulge in one area After the splicing was completed, a thin layer of liquid electrical tape was applied around the bundle and then when that set up, the bundle was tape wrapped and finally covered with the “smurf” tubing.

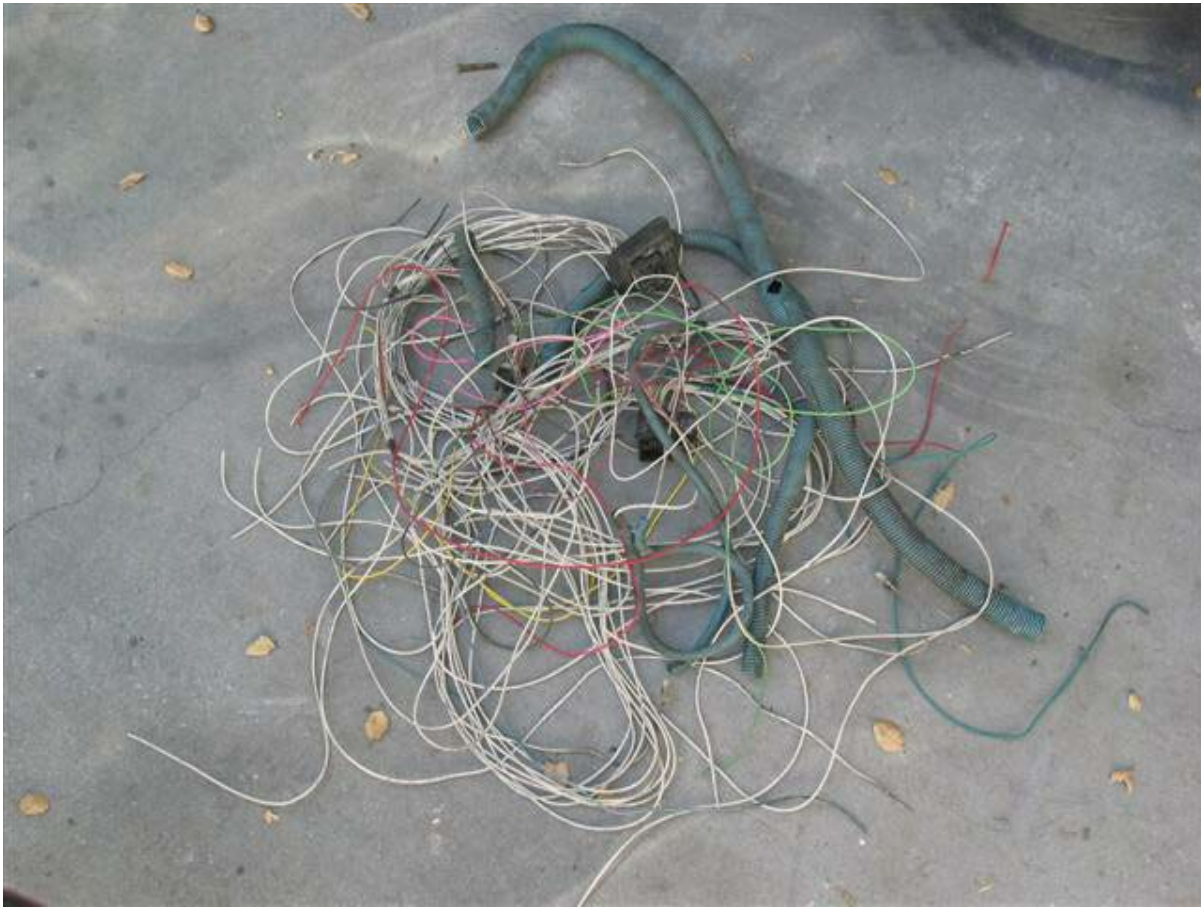
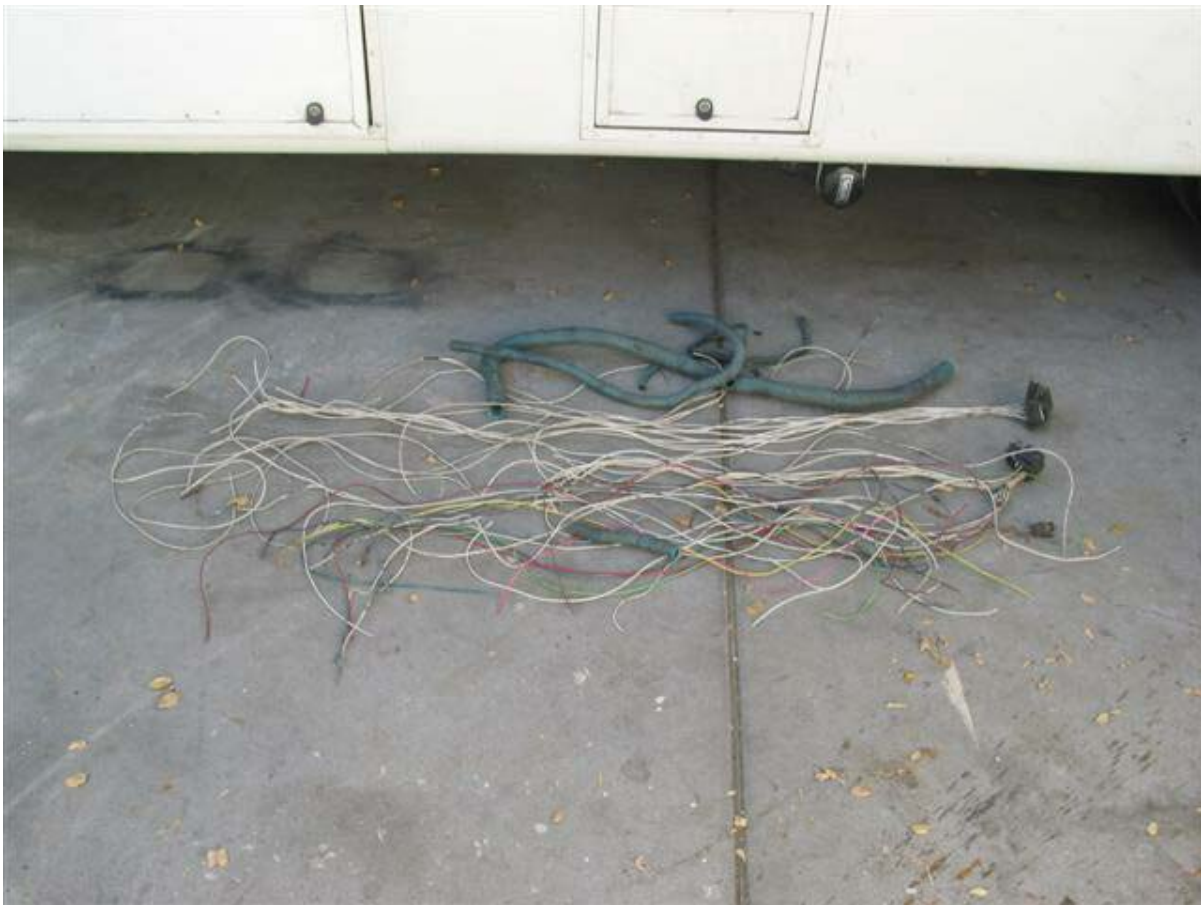
Here is what was left over!
