Taillight clean up and retrofit

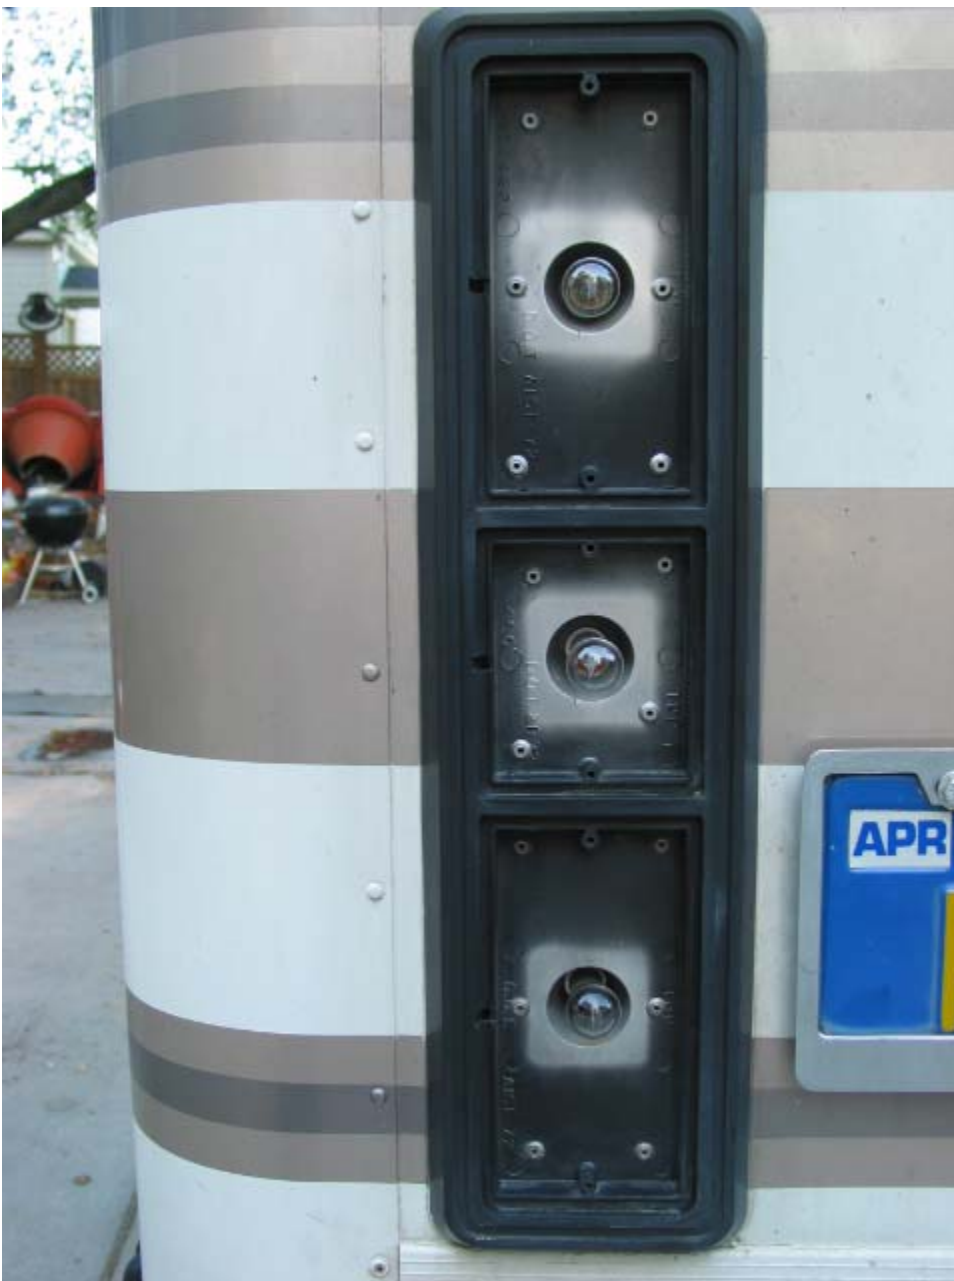
Very dirty inside with lots of dust/dirt in the lens grooves.

The back side of the assembly was black plastic! Nothing reflective at all! Just a little silver paint around the light bulb area. Right side had no paint at all!

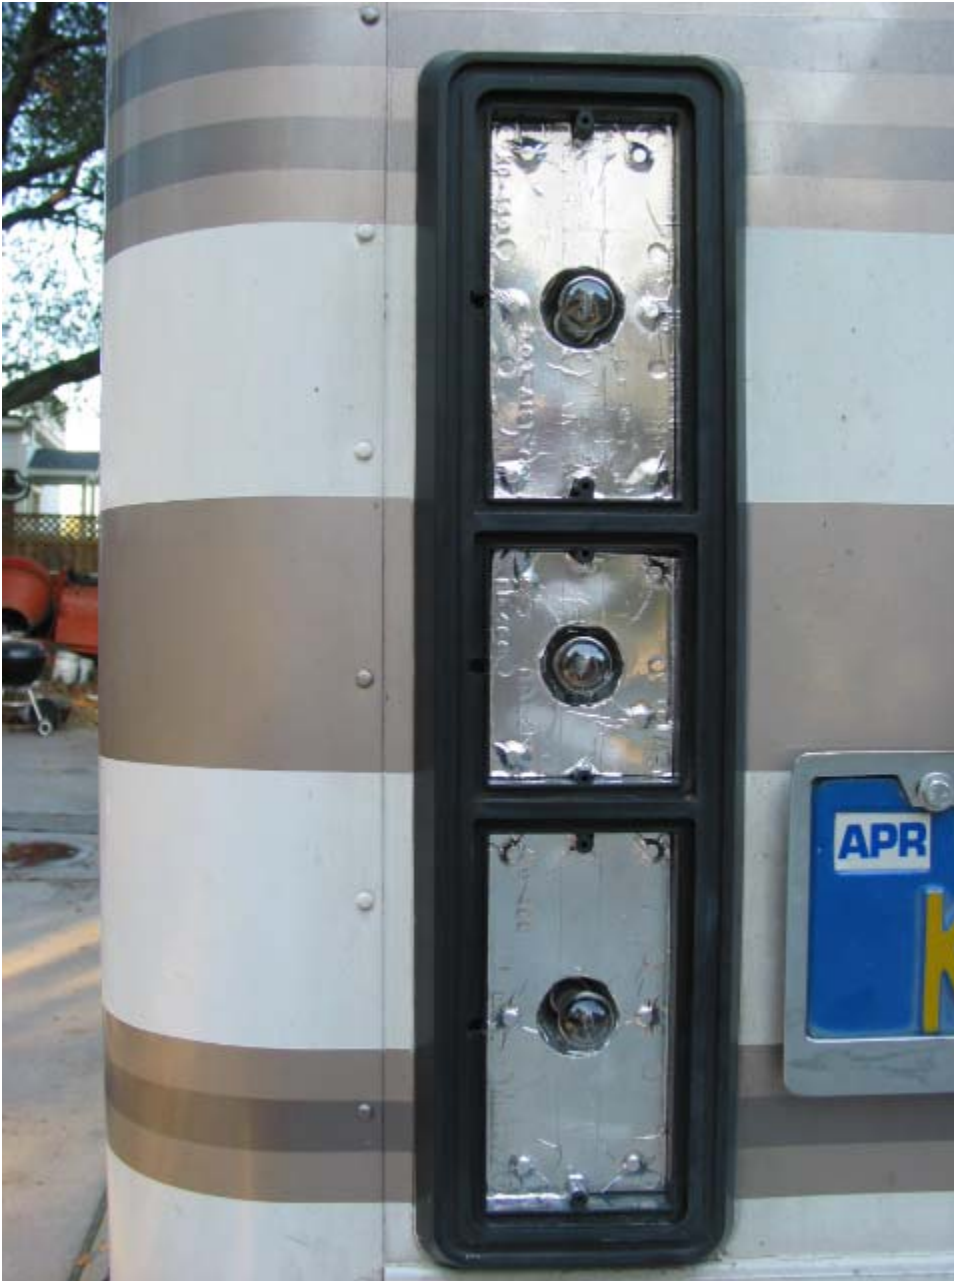
This is 3M heat tape but is very shiny I have used this tape before in other car's tail light assembly with good results

I figured I could make the lights brighter by placing some reflective tape on the area all around the light bulbs.

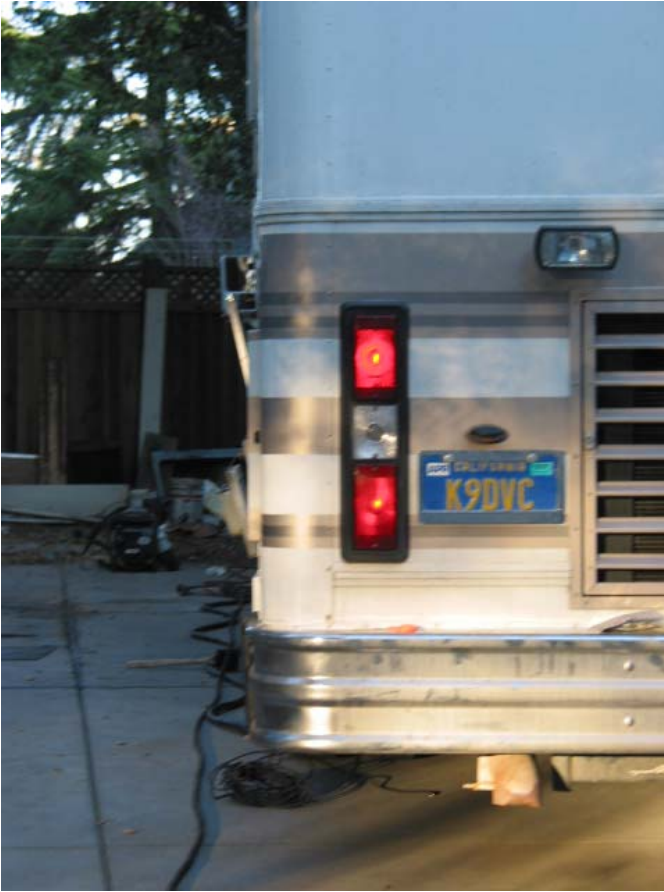
Notice that the lamps are very full now!

This is a little deceiving because there is bright sun light on the left side and mostly shade on the right side, but the results are very obvious!
