Brake master cylinder replacement

8-25-2010

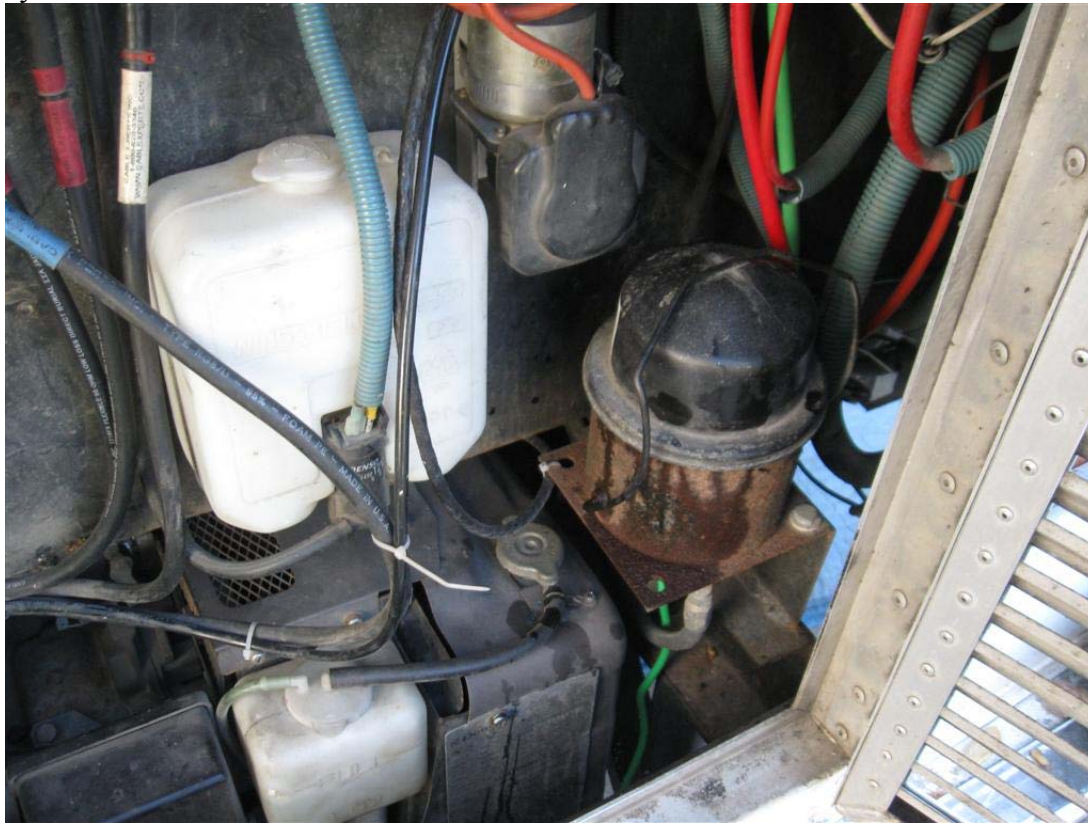
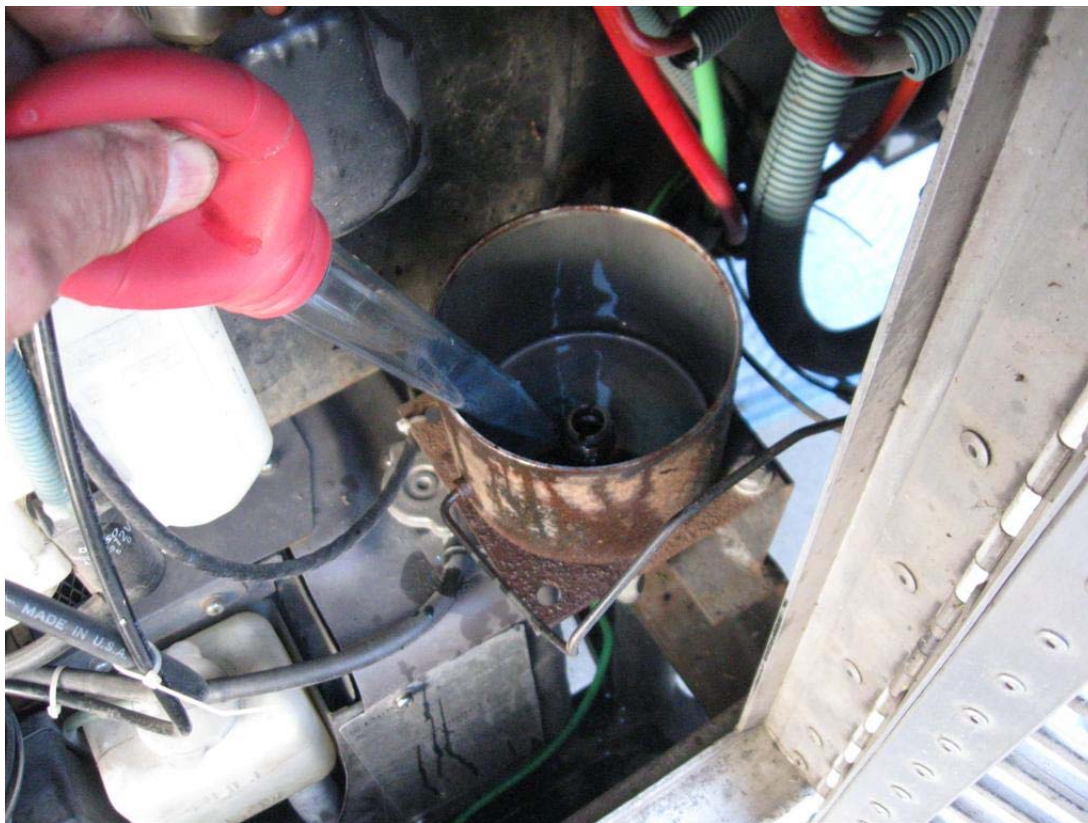
Start by locating the brake fluid reservoir and then use a CLEAN baseter, remove all the brake fluid, do not operate the brakes while the canister is empty, the canister supplies both front and rear master cylinders.

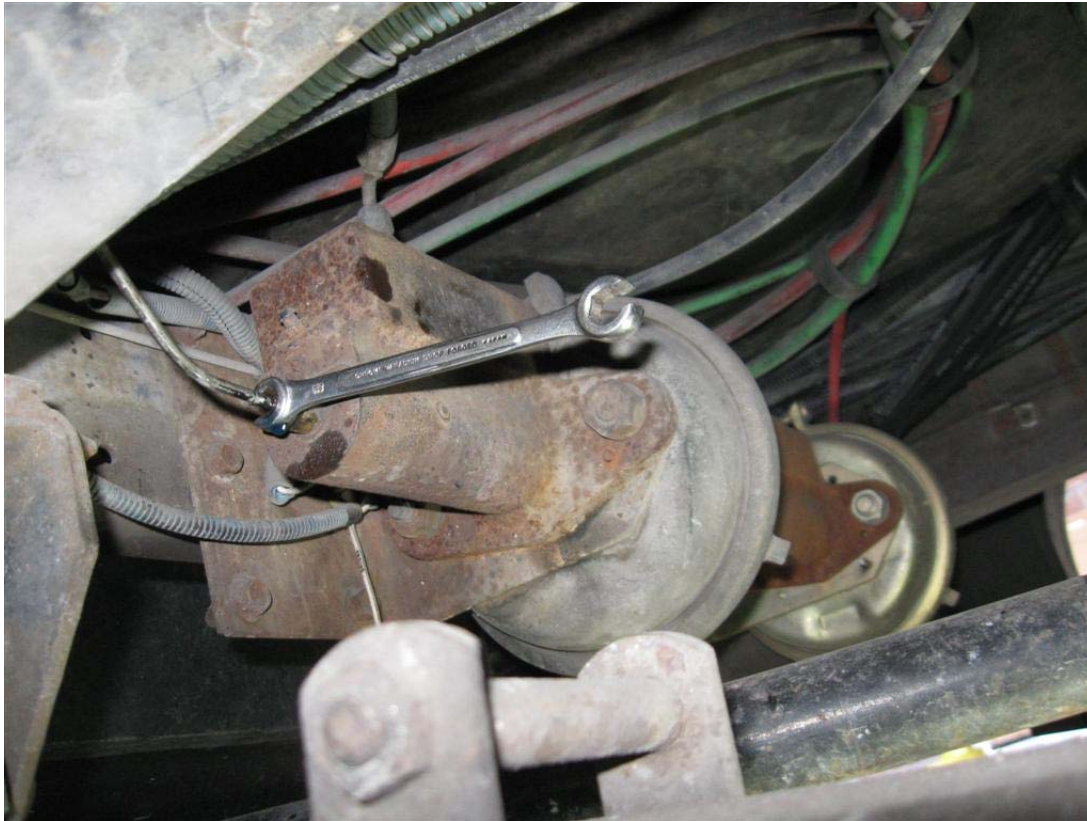
After the canister is empty, loosen the brake line from the master cylinder and let it drain into a cup, will save a lot of mess later.

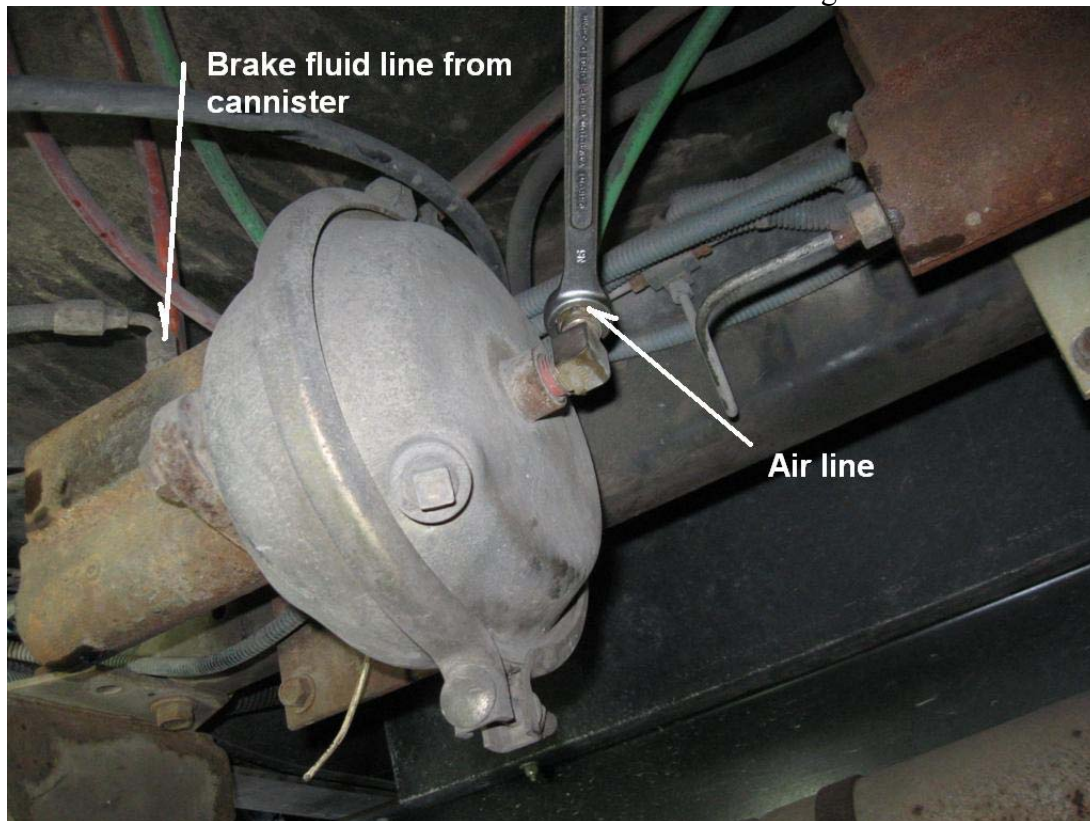
While draining the master cylinder, remove the air line and the brake fluid fill line on top of the master cylinder. Also remove the electrical connection to the brake warning switch on the air canister.

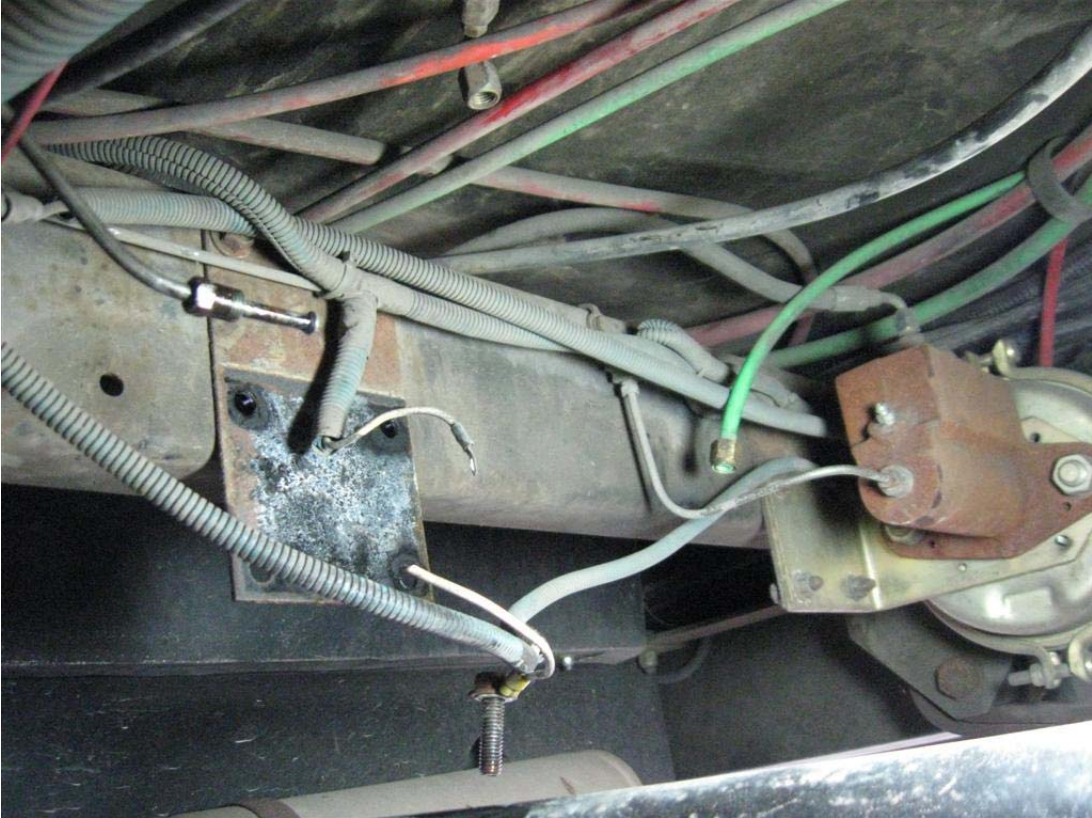
Remove 4 bolts holding the assembly from the frame member and remove the master cylinder assembly.

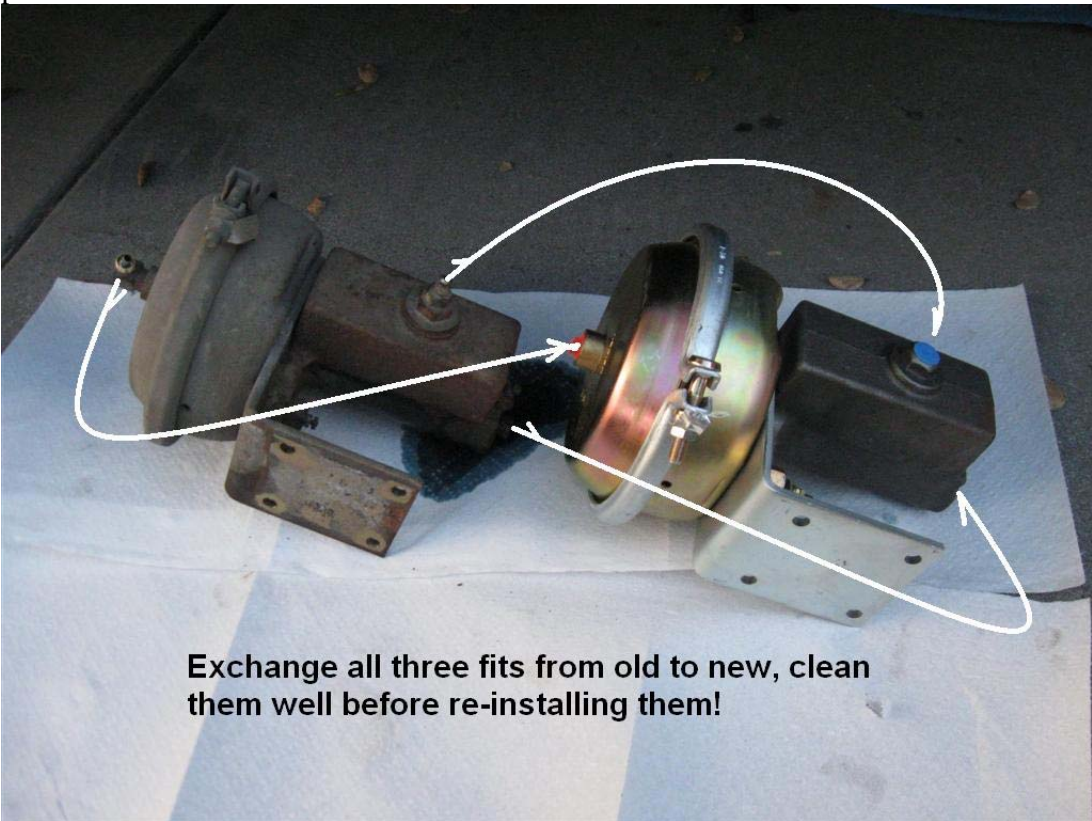
Once the old master cylinder has been removed, exchange three fittings from the old master cylinder to the new one. There is a "O" ring on the top fill connector which should be replaced and there is a CU crush washer on the brake line connection that should be replaced, Can be purchased at a good full service parts store.

Exchange all three fits from old to new, clean them well before re-installing them!

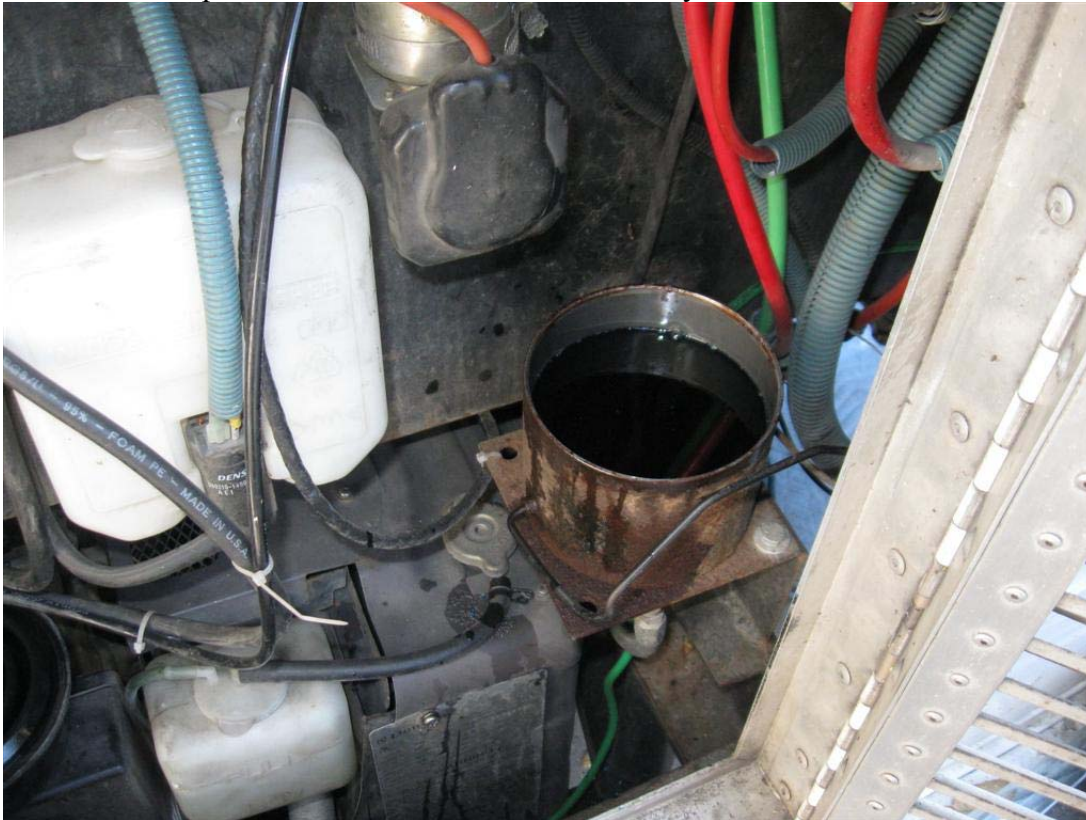
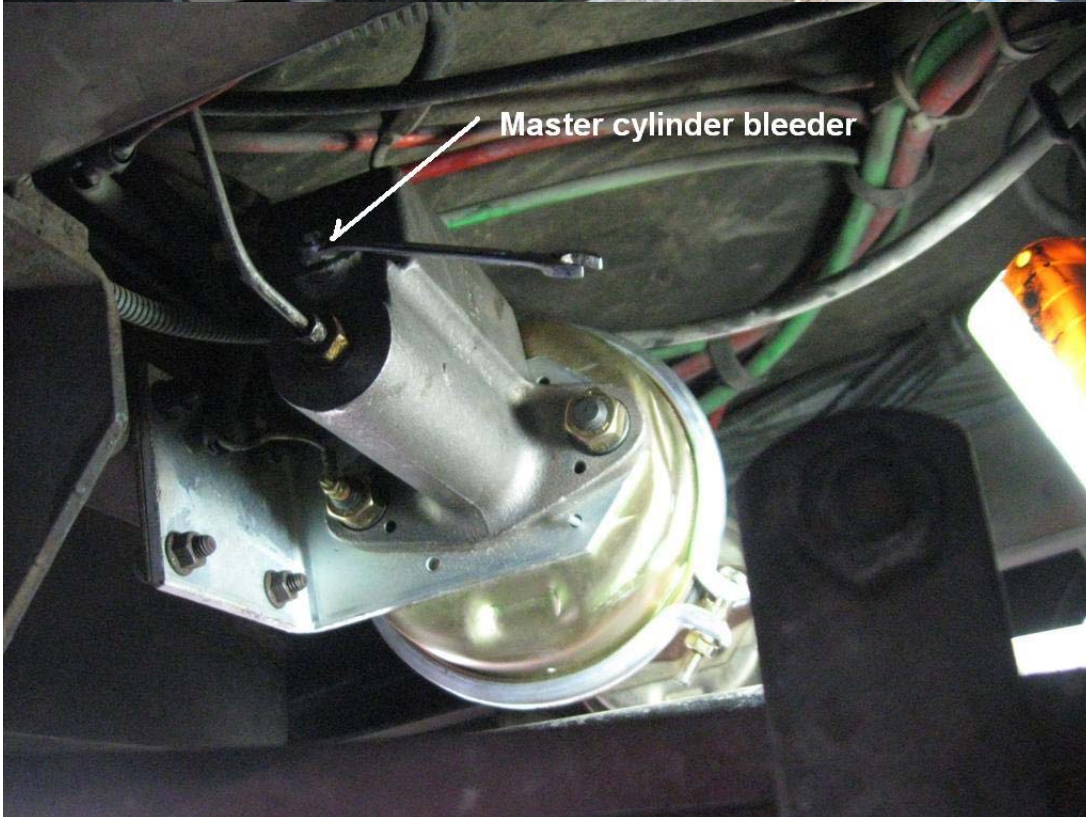
After all the connections are made, brake fluid fill line, brake line, air line, and electrical connection, it will be time to bleed the master cylinder. Fill the fluid canister with fresh fluid and check for leaks on the fill line. Then open the bleeder screw on the master cylinder

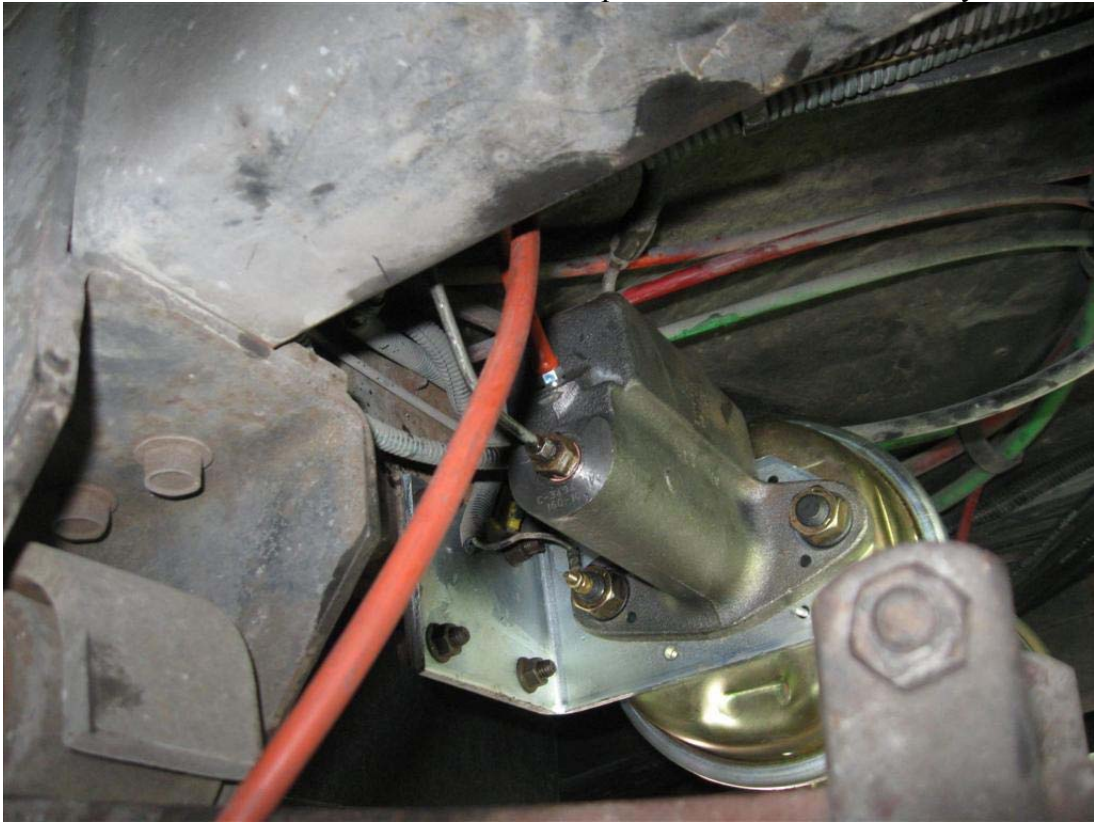
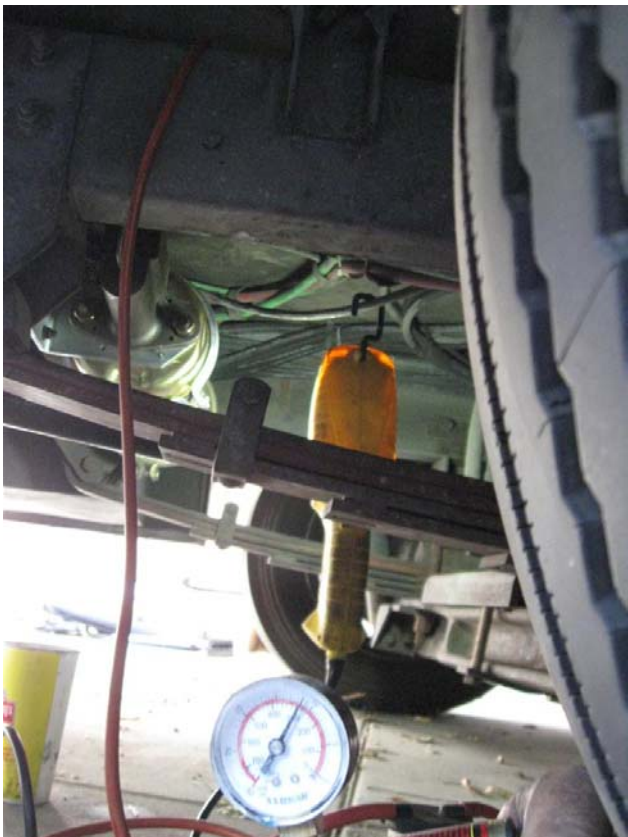
If one has a vacuum bleeding system, it will greatly speed up the process, attach the vacuum hose from a small bleeding bottle and pull a vacuum with a small hand vacuum pump, once there is fluid pulled out into the small bottle close the bleed screw and proceed to bleed the entire system.
