Fuel tank filler location change

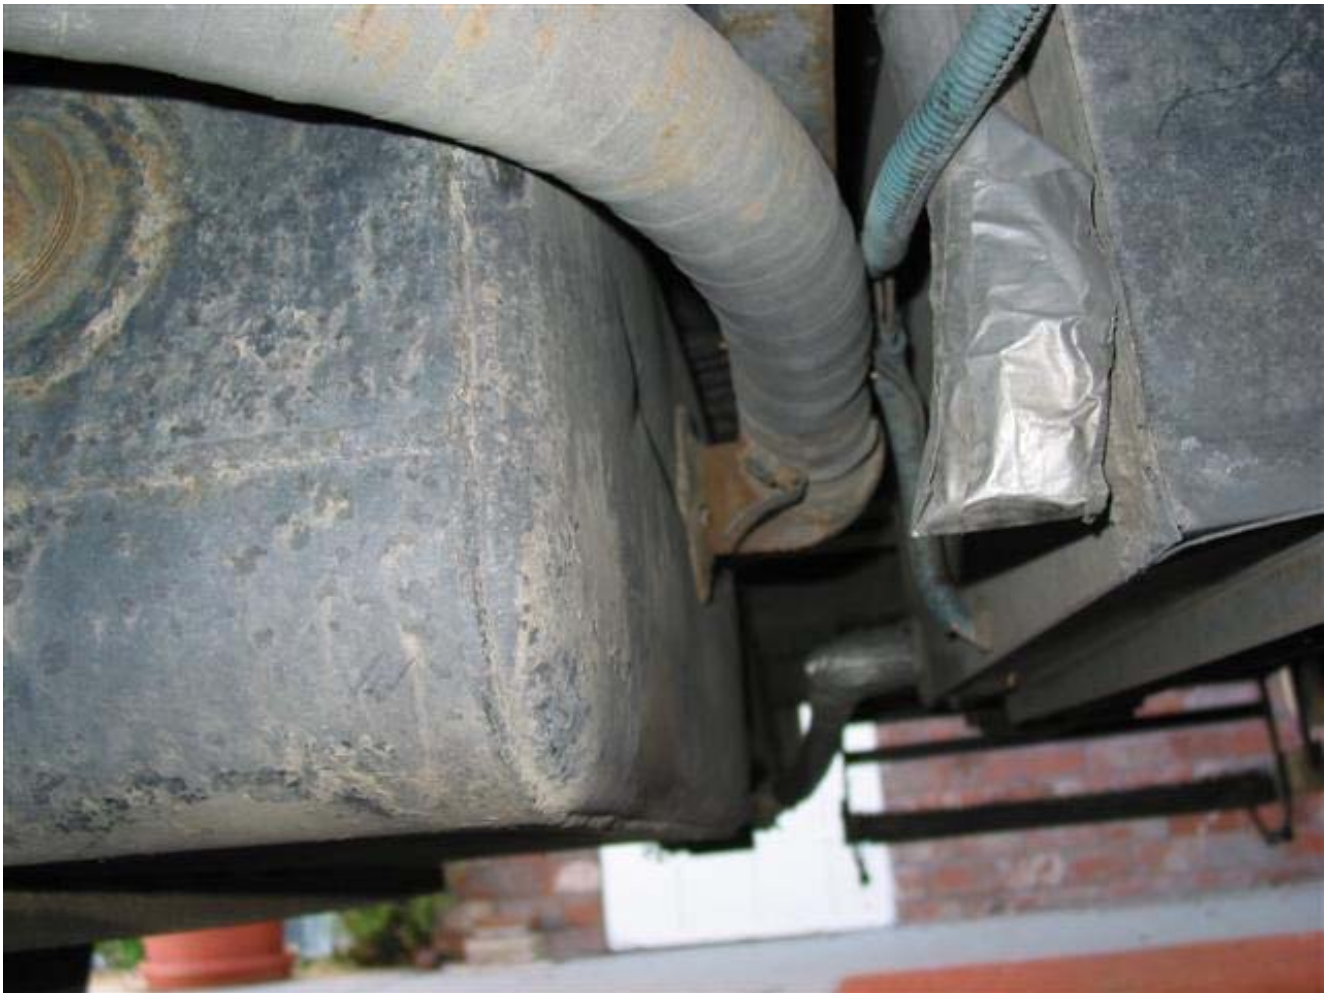
Rear tank filling point:

During travels for the last 35K+ miles I have become increasingly frustrated by the LONG refueling times required to completely fill the fuel tank, It was obvious where the trouble was, the filler was routed to the tank and the entry point was about half way up the side of the rear of the tank. Once the fuel reached the level of the entry point, the filling hose will fill with fuel, foam back and shut off the automatic filler. From that point, it required hand filling with the slowest possible rate to avoid foaming, the tank vent would allow air to escape and the tank could be completely filled but was a VERY slow process and sometimes messy!

After looking at the tank installation, I decided to remove the tank and have a bung welded into the front of the tank at the very top. This would eliminate the foaming because the filler hose would not fill with fuel and would also shorten the filling route, further eliminating foaming. I had determined there was sufficient room to route the filler hose over the top of the frame, between the frame and floor directly to a front filling location.

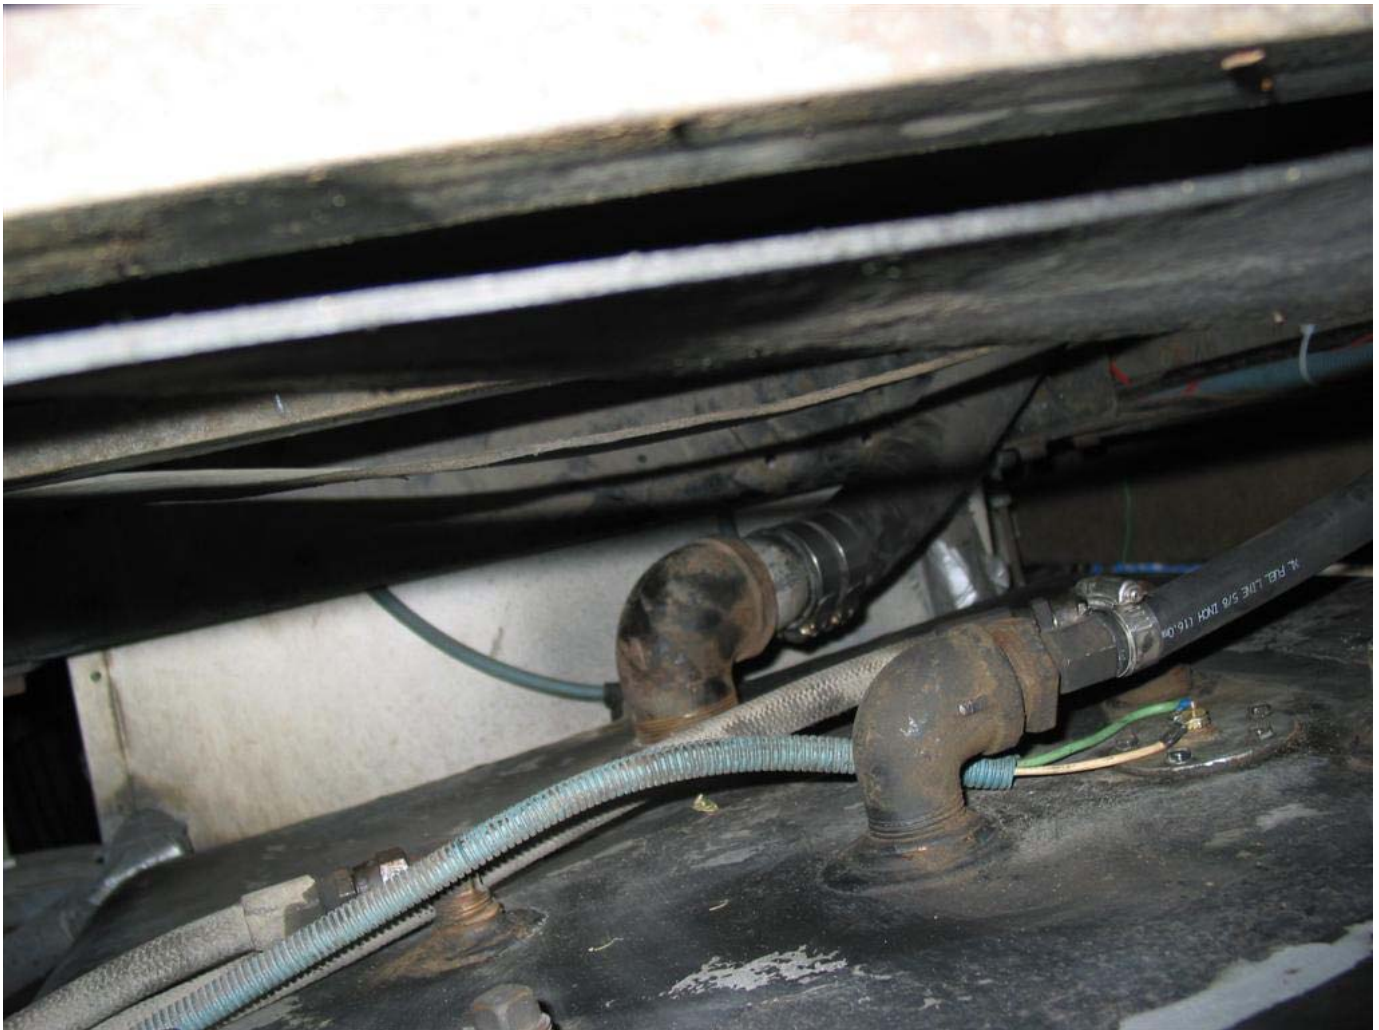
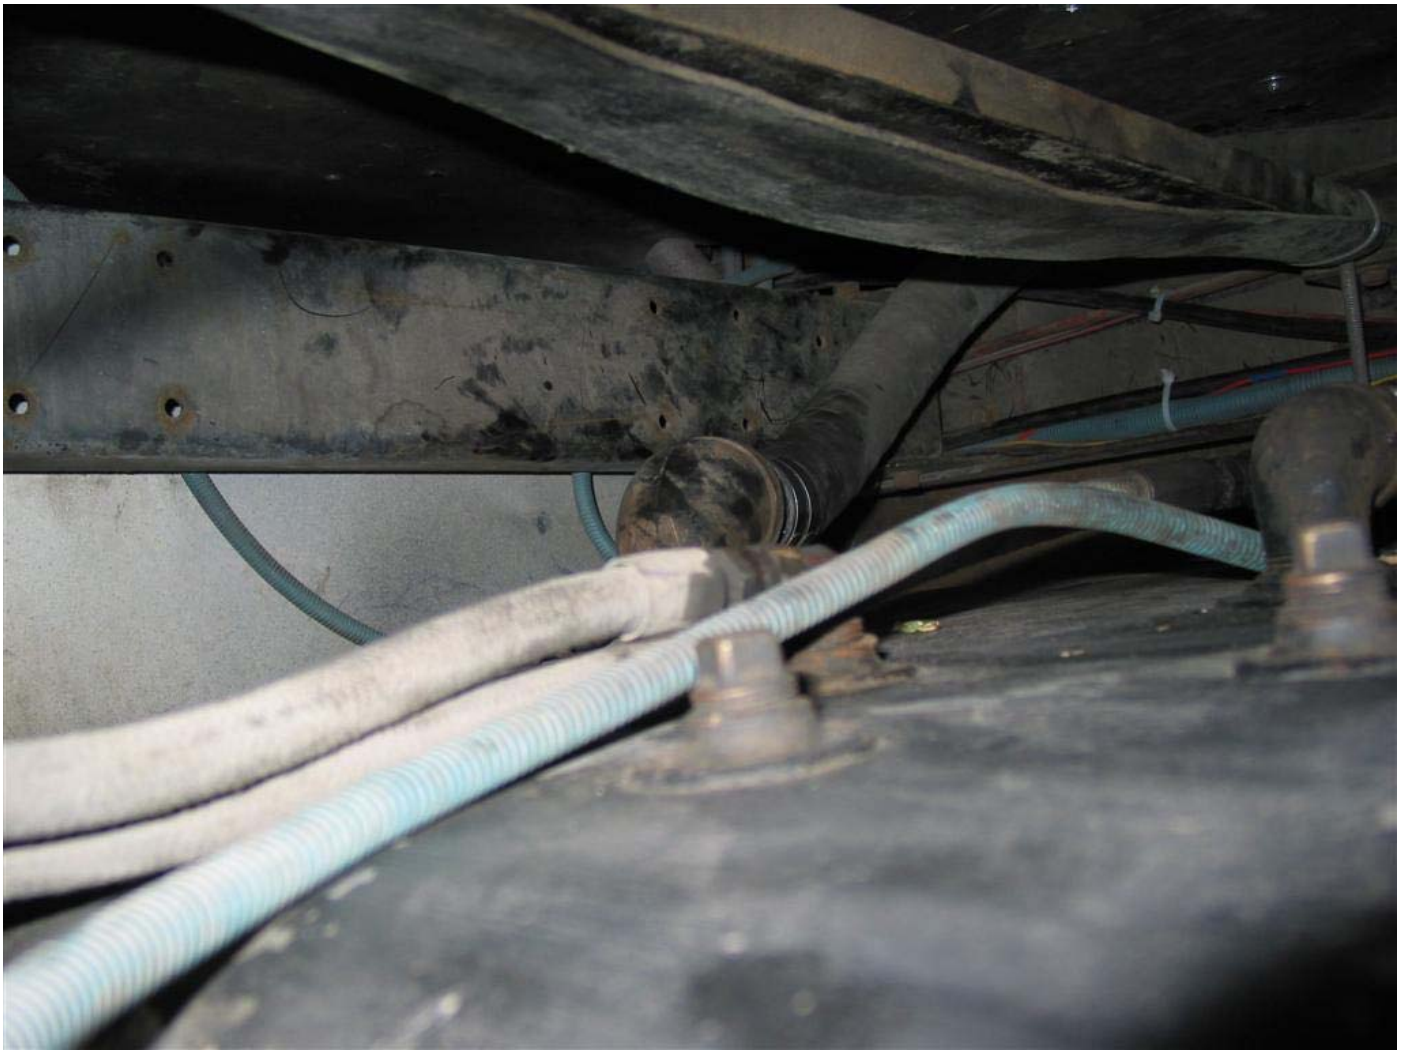
I had to re-route the heater hoses to the right side going over the fresh water tank and fuel tank so that they would not be crushed by the filler hose to the floor. I lengthened the breather hose and reinstalled the tank. I had to raise the driver's side of the tank as high as possible with the passengers side as low as possible to connect the filler hose (that bugger is stiff!!) and breather hose, all connections made the tank went into place without issues.

After the tanks was secured, I put the 15 gallons back in, fuel gauge was registering so all was good to go.
