# Instrument Panel Modification

Dec 20, 2008

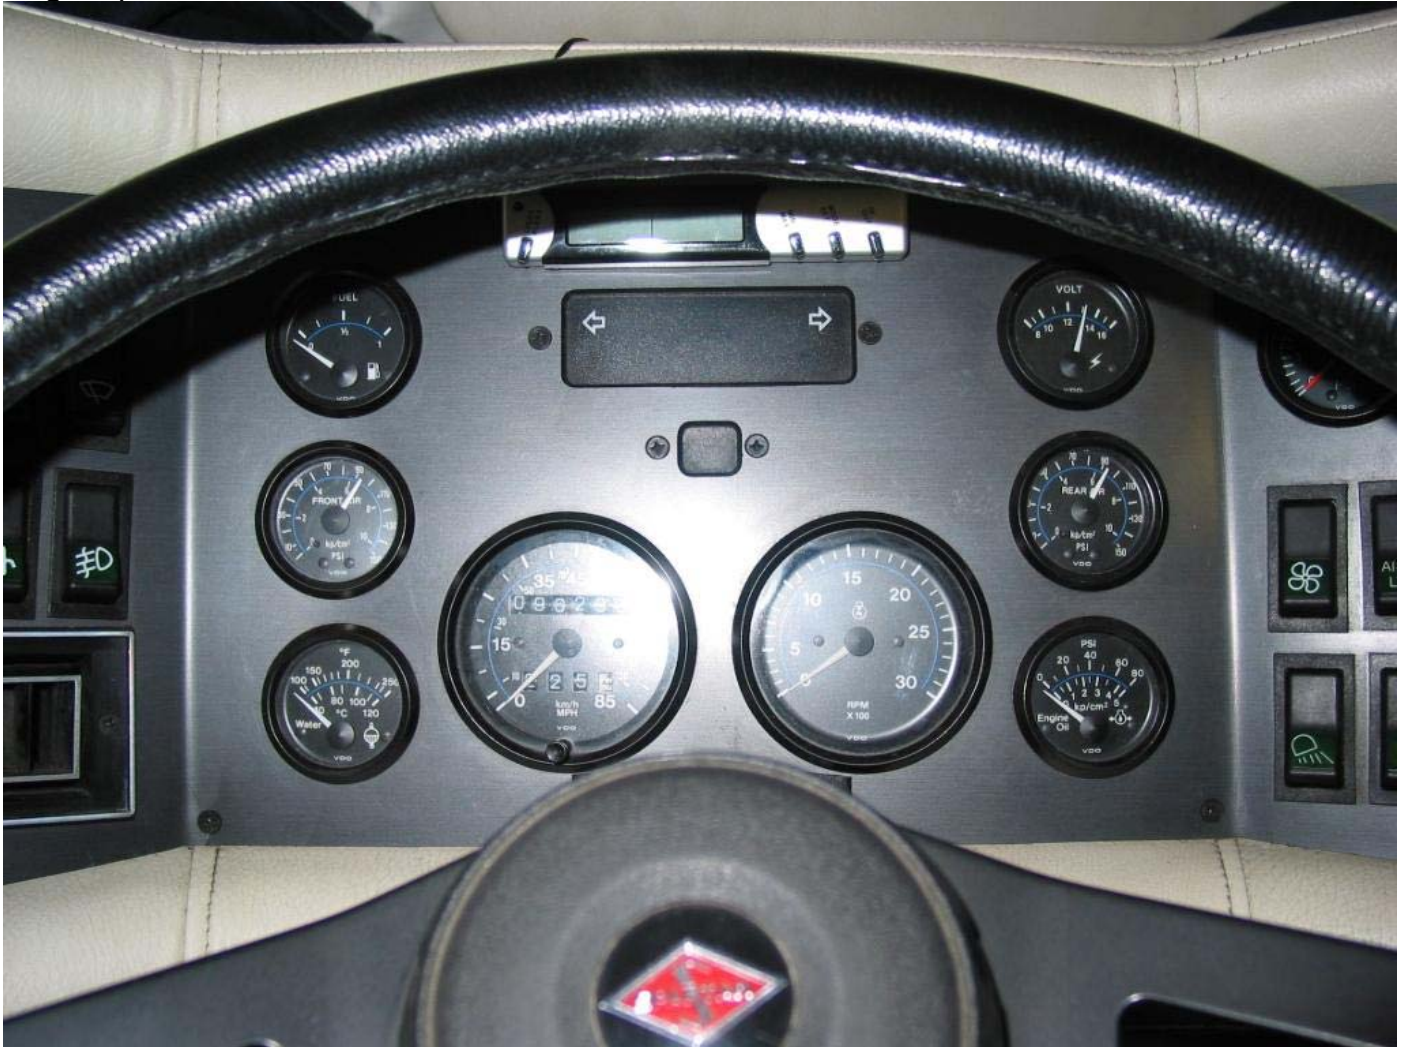
Original panel:

This panel was functional but I also had trouble viewing all the gauges as some were blocked by the steering wheel no matter where I positioned the wheel, fore/aft, up or down! The multi-light annunciator panel was always blocked. I had made a plastic periscope to show the lights above the wheel but it was always being knocked off when the wheel was tilted forward.

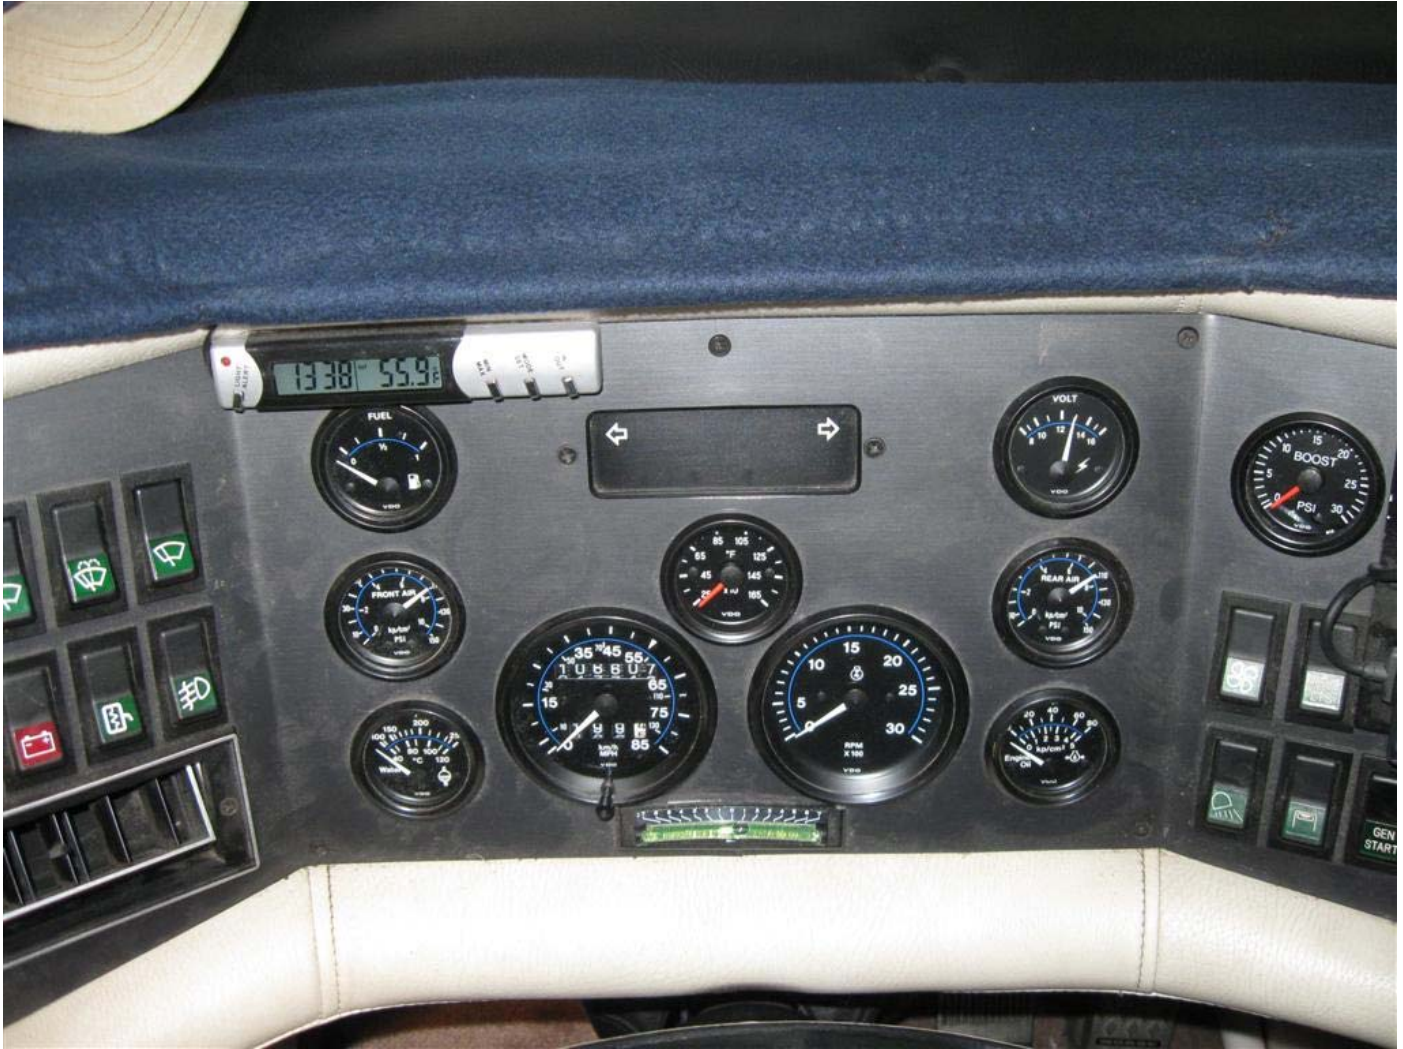
I modified the original panel by eliminating the warning light for “do not shift” just above the tach and speedometer. I carefully cut a hole and added the EGT gauge, I also added the turbo boost gauge where the generator hour meter had been. Figured boost was more important short term then generator hours. It was my intent to further modify the panel completely because in addition to adding more gauges, the panel, made of plastic, was starting to crack around the retaining screws and pieces of plastic were falling off.

The above layout worked for most of the past summer, but I had intent to add a trans temp gauge and was running out of options where to locate the next gauge.

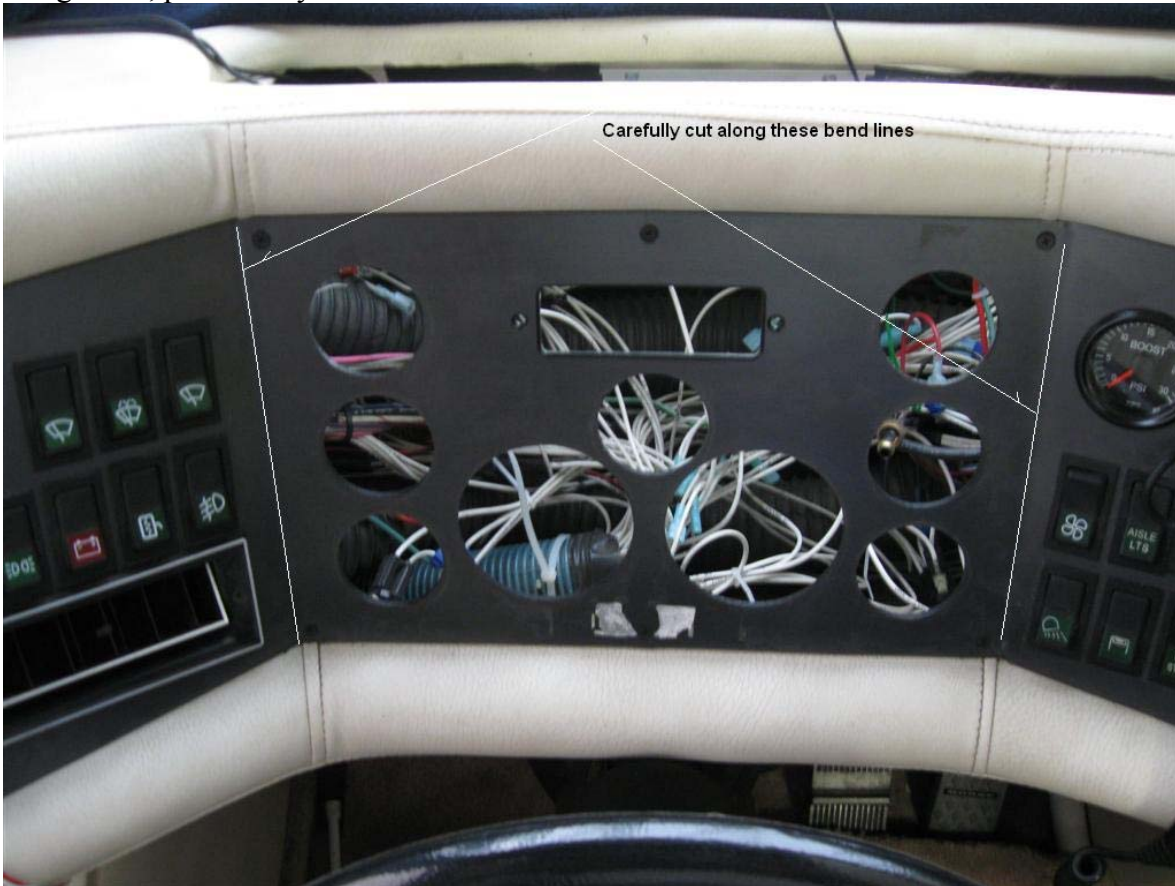
Gauges out, panel ready to be cut out:

The previous picture should show what was done to remove only the center section of the panel, I used what is called a Feinsaw with a very thin blade hoping to make a small incision that the new panel would mate to with little effort. Unfortunately this was not to be the case! No matter how quickly I got in or out, plastic would melt due to friction and caused a rather sloppy edge. My previous measurements were good so the new panel of aluminum did lay right in but the mating edges to the existing plastic panels wasn't as clean as I liked.

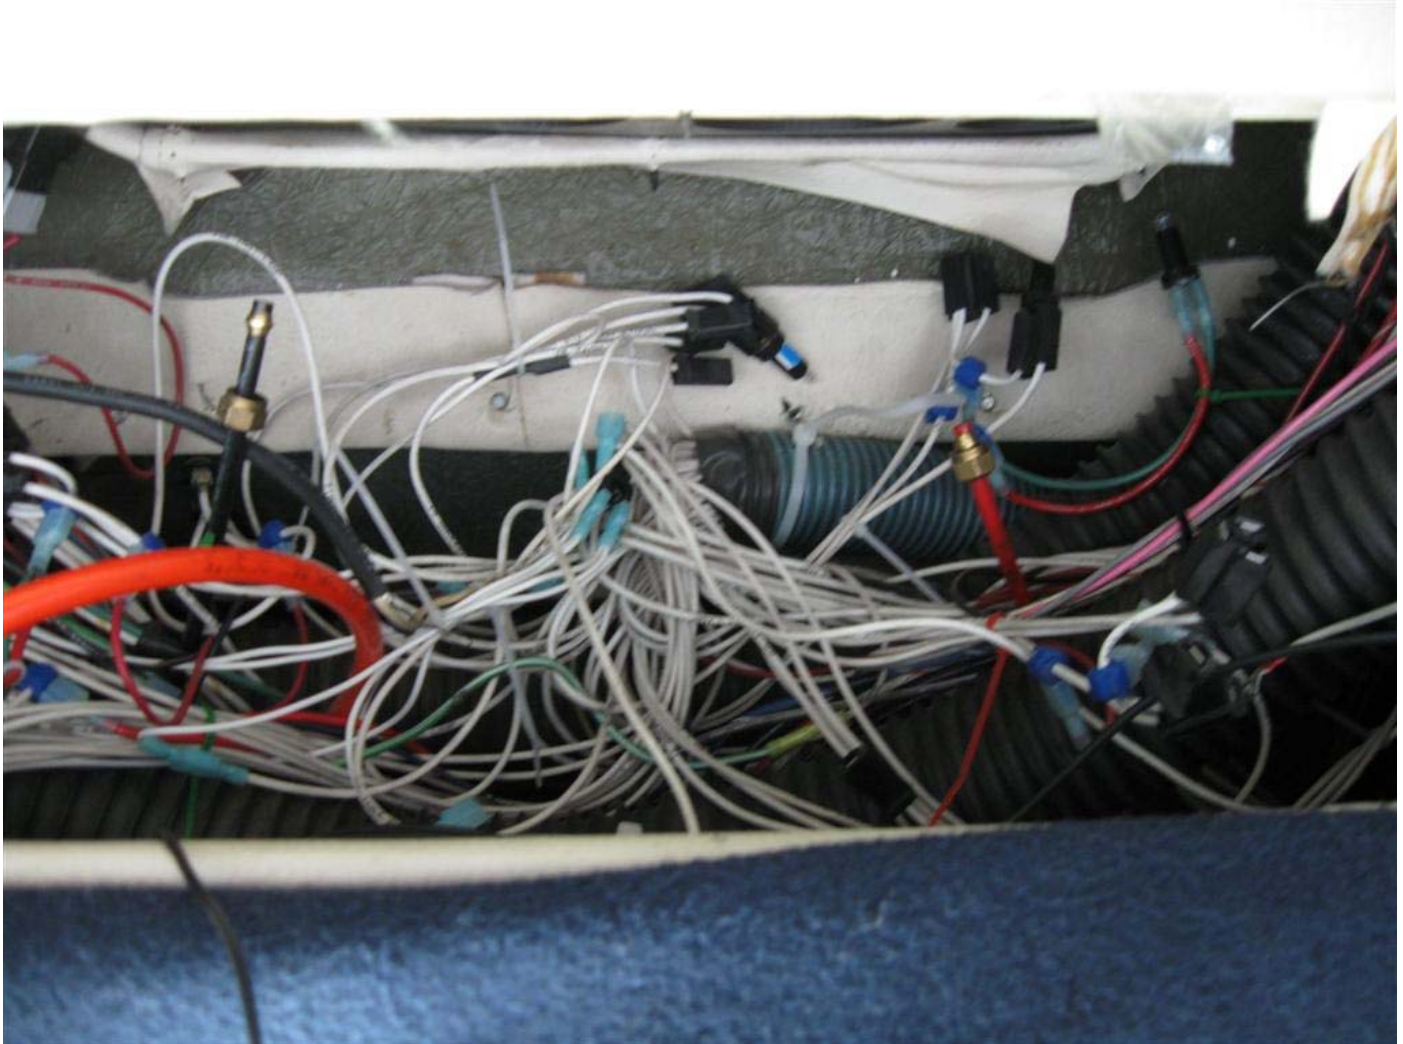
Panel out, getting ready to clean up the wiring mess:

Before attempting to put the new panel in, I started to clean up the wires and bundle all the wires for each gauge together, knowing that it would be impossible to get it really harnessed right but would be an improvement over what I started with.

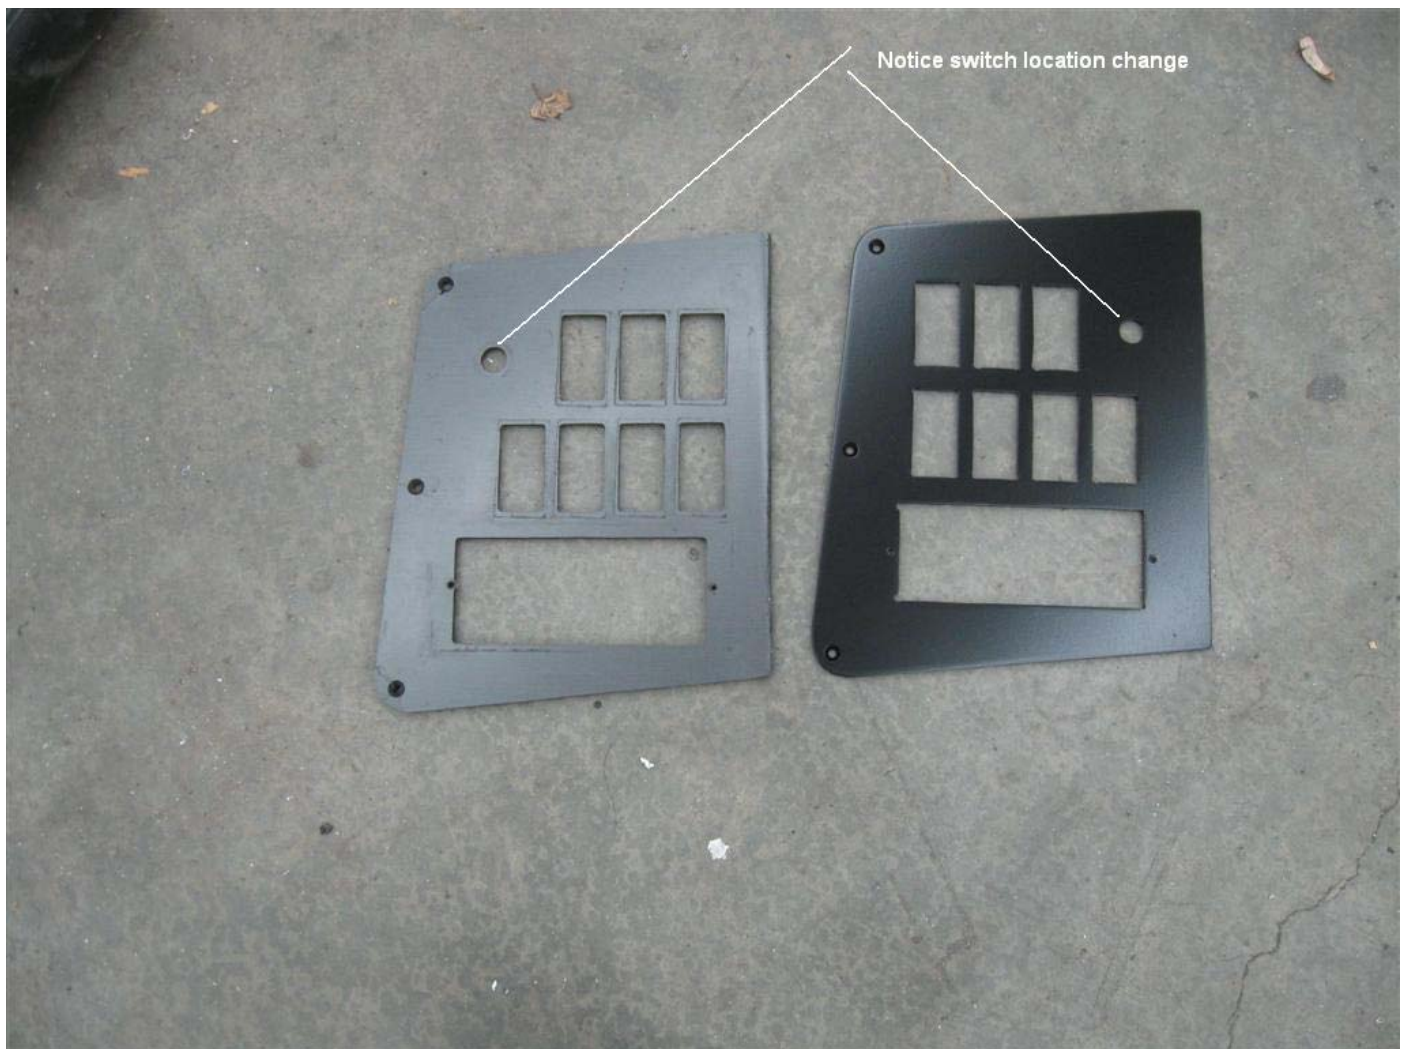
OK, time to replace that panel! With the instrument panel out of the way it was fairly easy to remove the wiring from the backs of the switches, labeling as I went along. Looking at the panel I decided to switch some of the switch locations. I reasoned that the light switch is usually turned on once per run ( I run with main lights on at all times, day or night) so it shouldn’t get in the way of wiper switches or others that may be used occasionally during a run. I also didn’t like the wiper switches left and right to be separated by the washer switch. With the switches out the panel now was a good template to use for over all sizing and layout change was easy.

Care had to be taken and a special angle cut made where the switch detents where to hold the switches in the panel. The switches were made to mount in a thinner panel then I made (even the plastic panel had a relief cut). After final trial, the panel was painted and installation began.

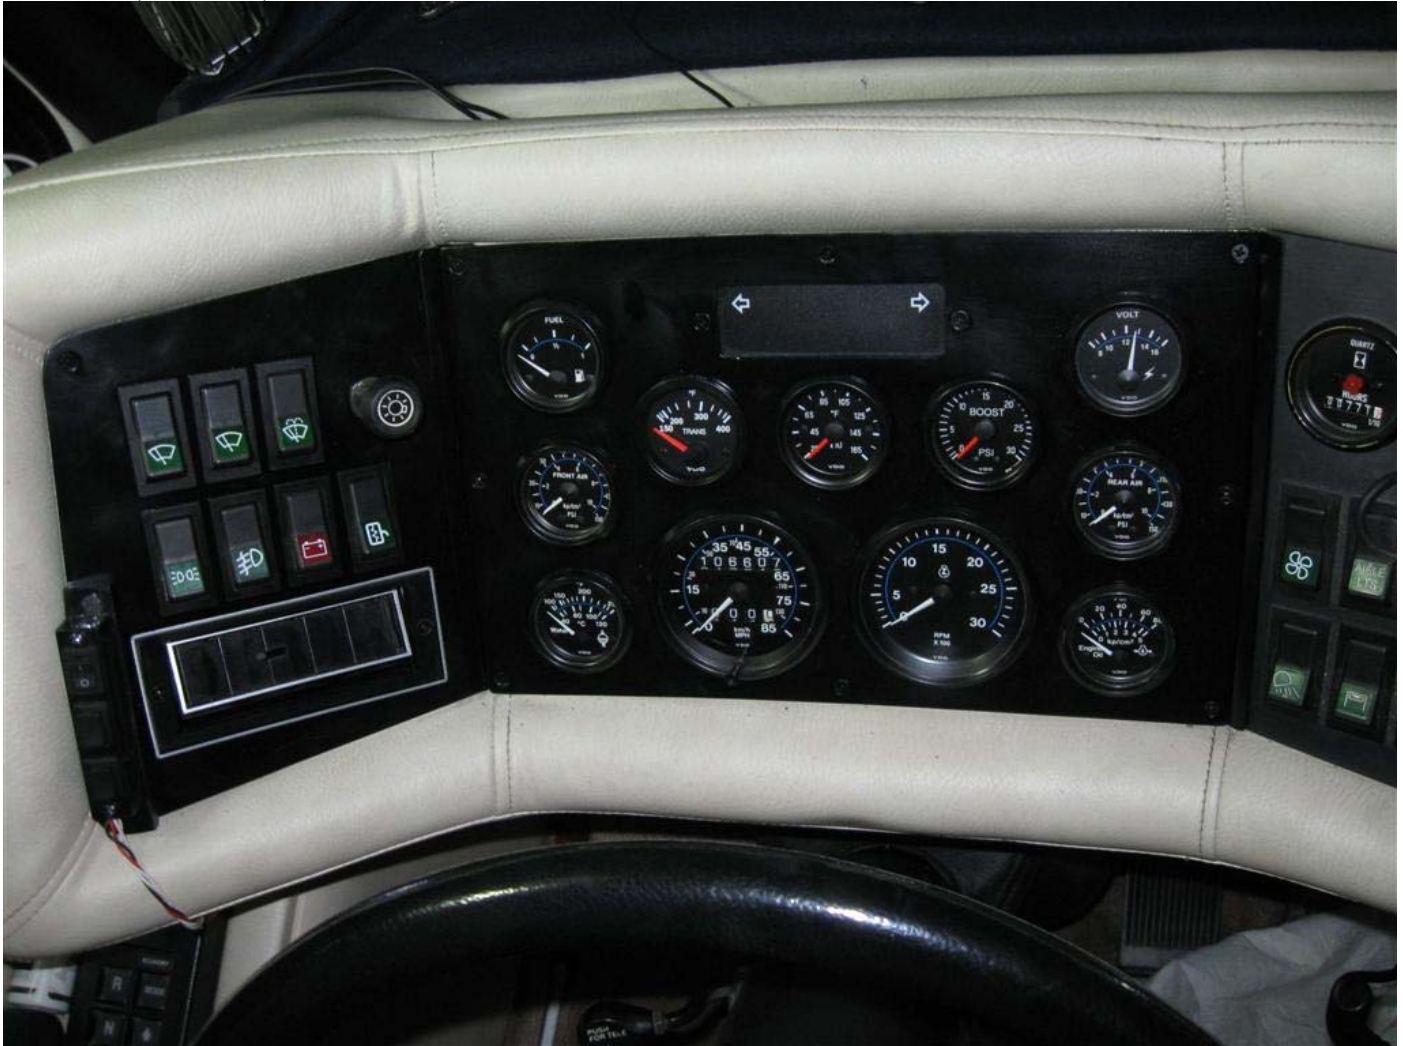
Finished: (for now!!)

Everything went back together very well. I like the new layout and although I still have visibility issues with certain areas of the panel, the crucial gauges are in plain sight.
