Exhaust Manifold Replacement

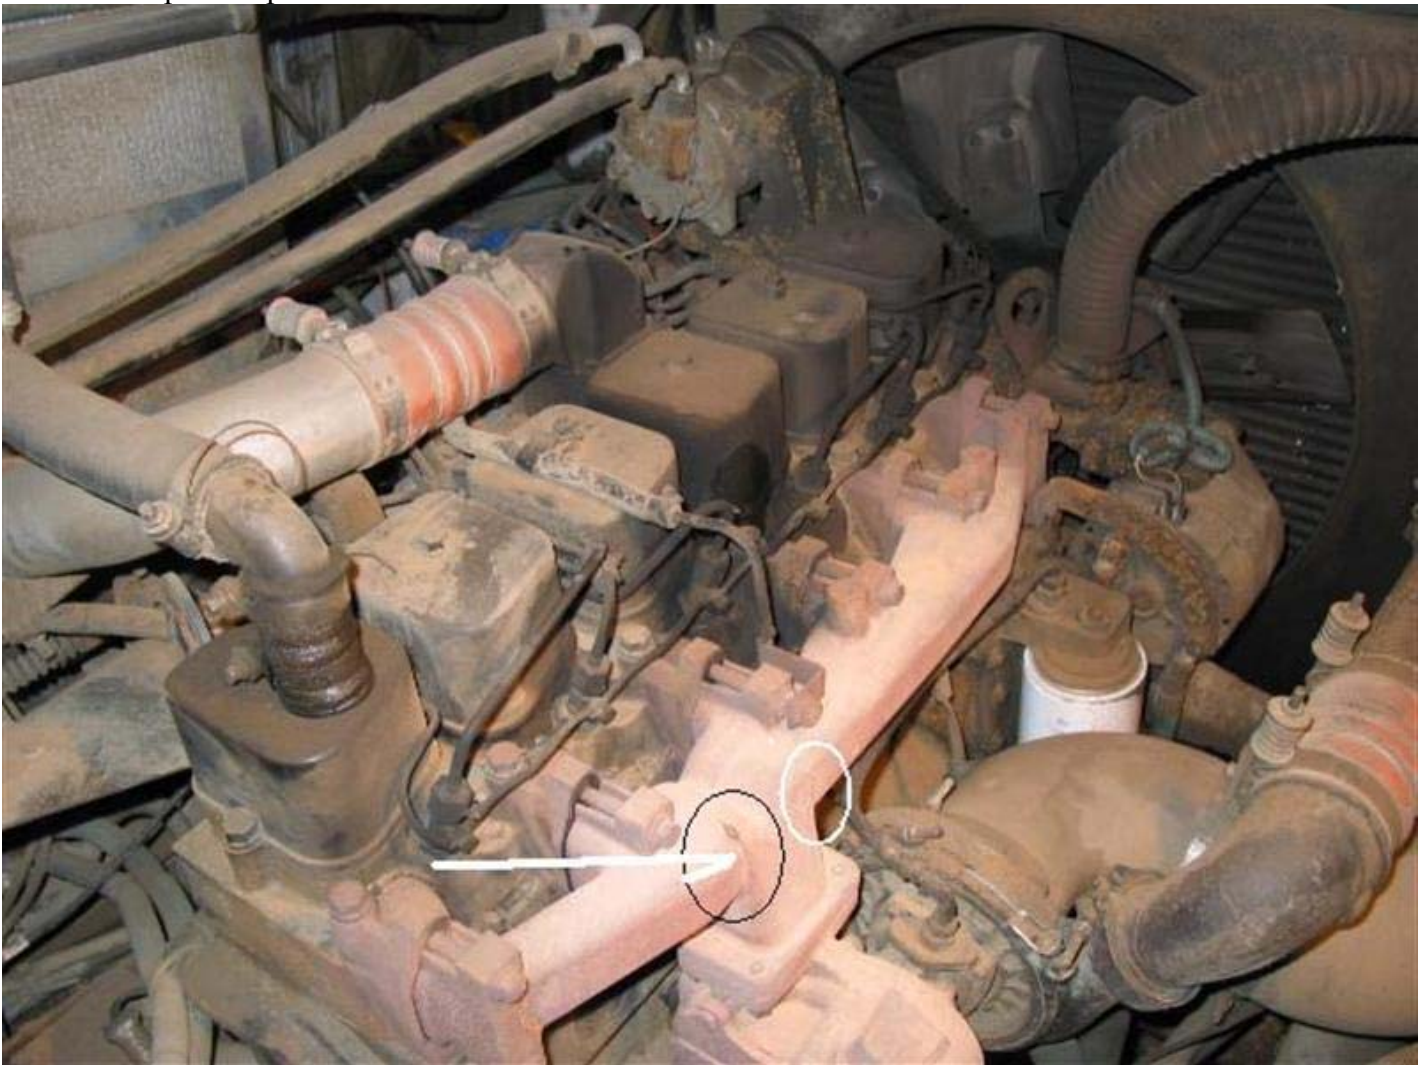
When I lifted the bed and got into the "engine room", I noticed a black smudge on the exhaust manifold that I had not seen before. Looking closely at this area revealed a crack, looking at the other side of the manifold, there was another. It is interesting to note that I had seen the "line" on the manifold before but dismissed it as just a casting mark. Going back to the original pictures I took while inspecting the Barth for purchase, I noticed in the picture that the line was there also!

Purchase Inspection picture.

The engine was very dirty and dusty and that is the only thing that I noticed but the crack was there and leaking!

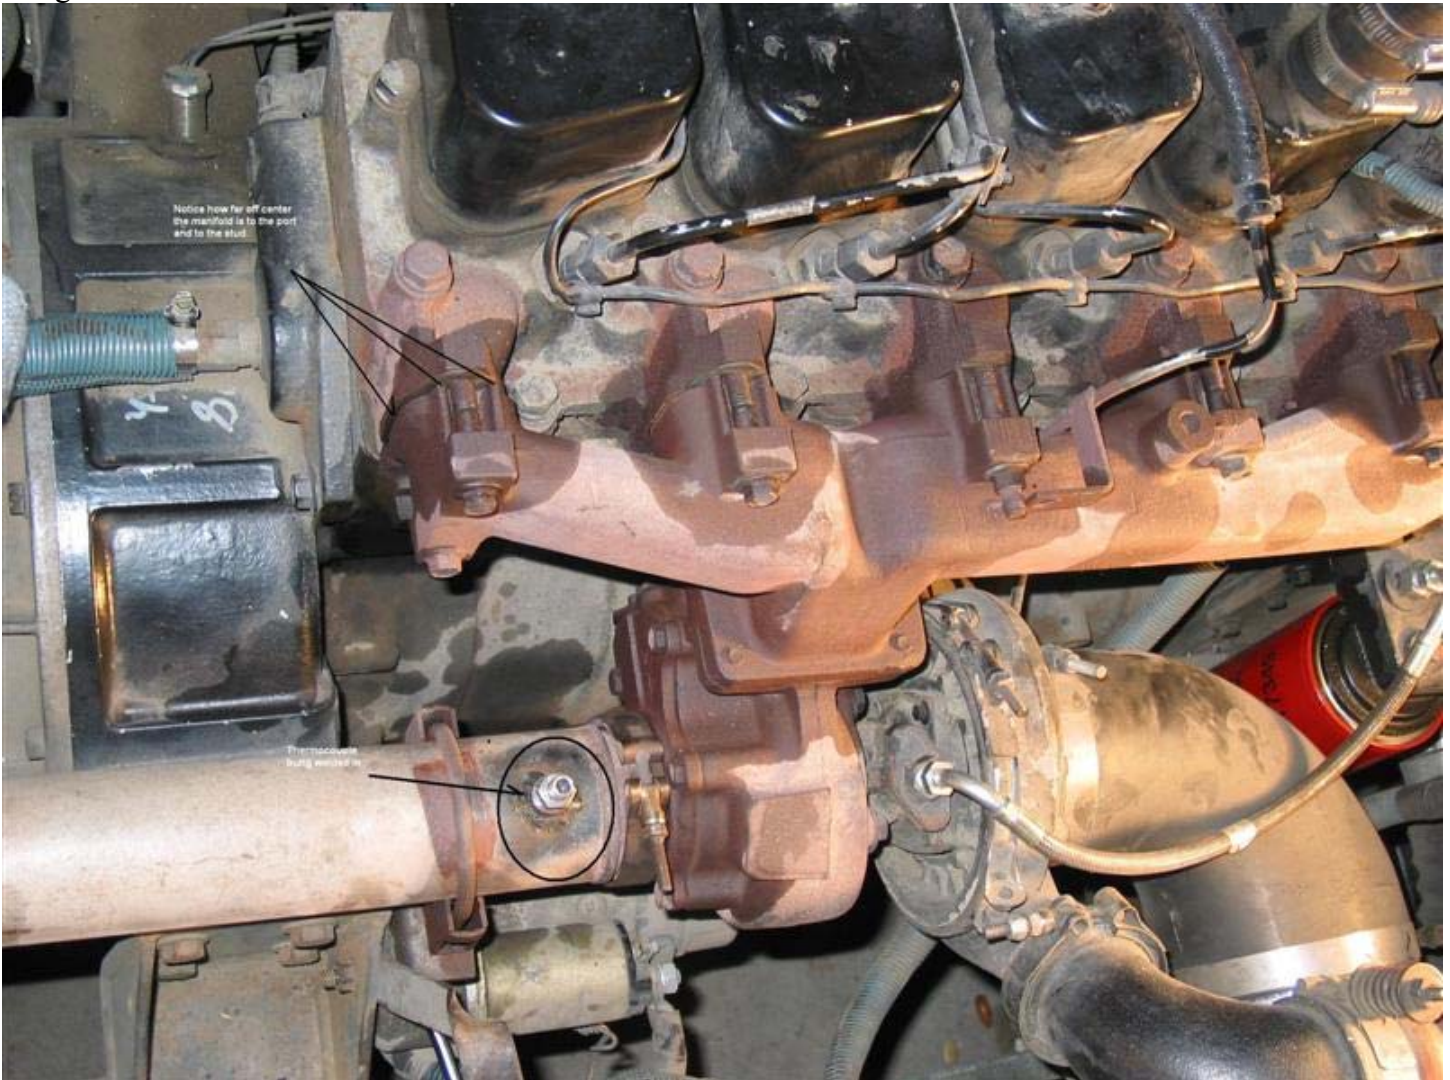
Bung welded on:

I removed the exhaust pipe from the turbo, sealed off the turbo and proceeded to weld on the bung for the pyrometer.

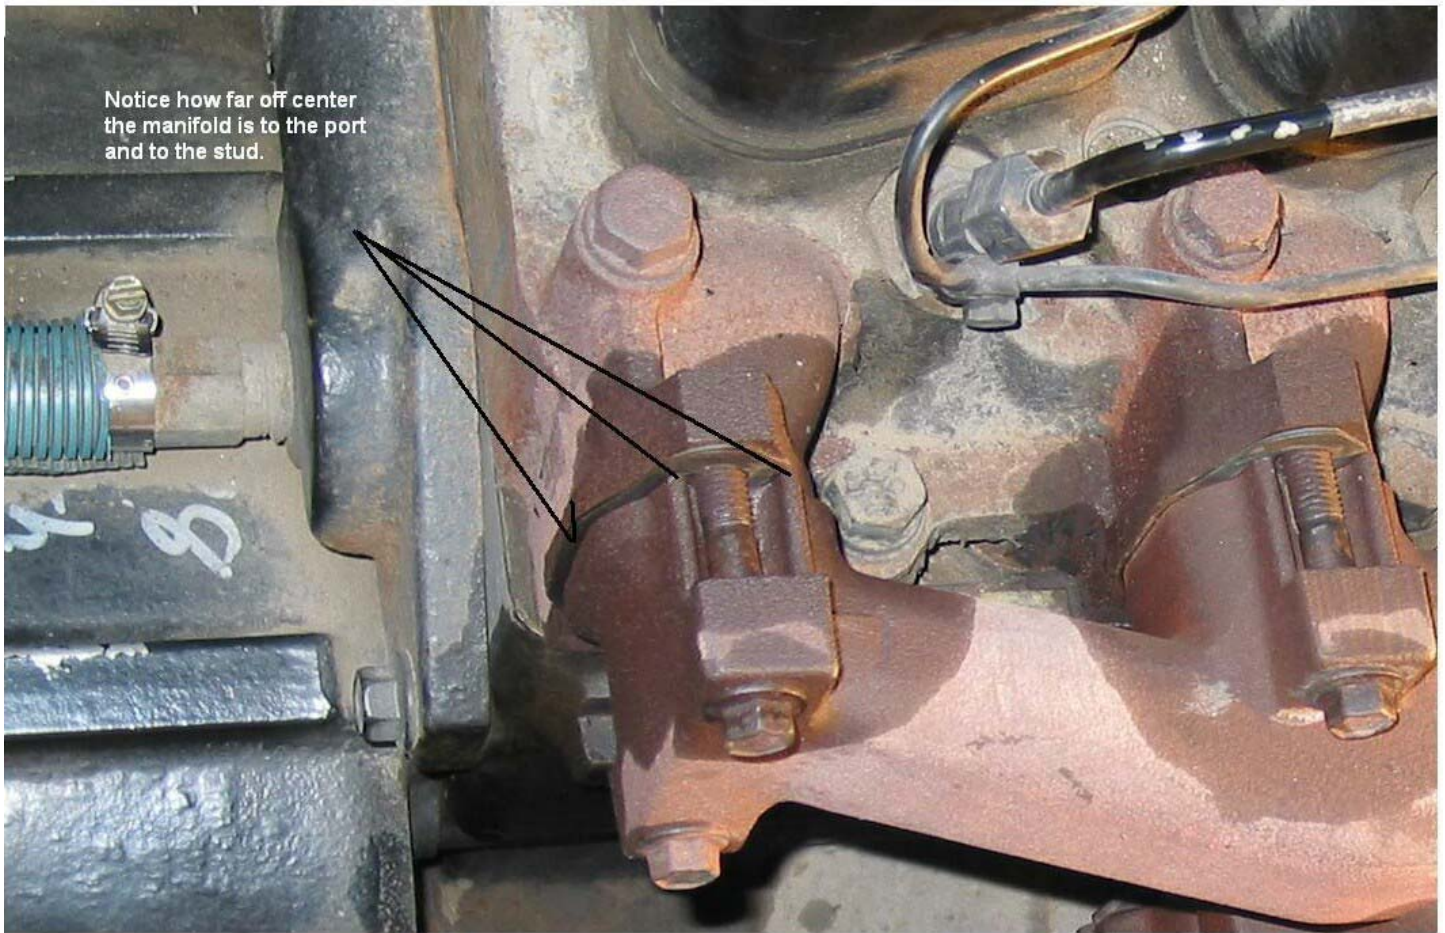
Then I noticed one other thing, The manifold appears to have shrunk!

That did it!! Went to get the new manifold, gaskets and new air supply line to the turbo as the old one was very rusty. I really was apprehensive about the change out, I had changed gaskets once before right after picking up the Barth so I know the header –to – head bolts would be OK.

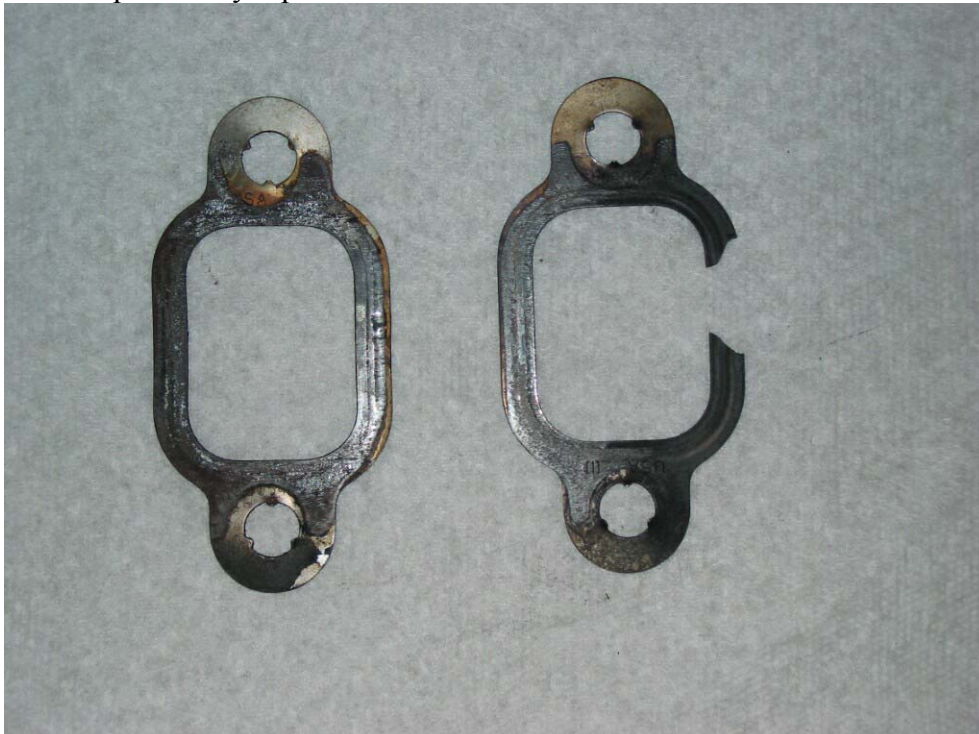
Gaskets previously replaced:

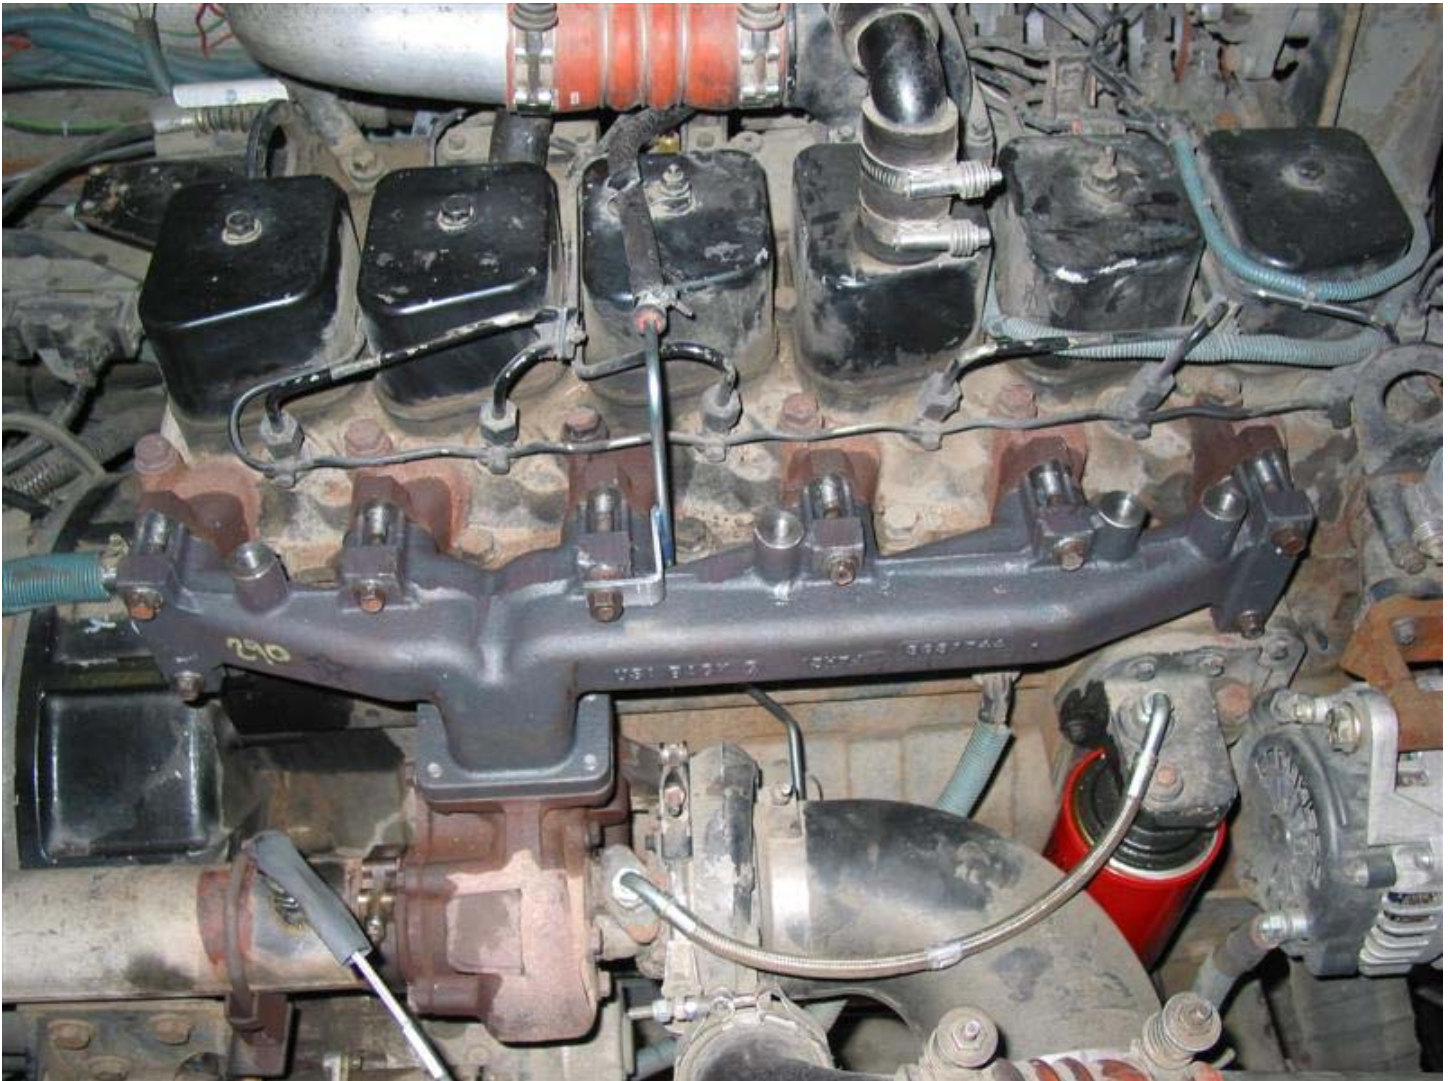
New manifold installed.

I was worried about the turbo nuts, I don't think they have ever been off. Much to my surprise, everything came off easily! I did notice that the end cylinder header bolts both #1 and #6 were binding on the side of the header hole while being removed, a clear indication that the manifold had indeed shrunk. Total time to change for start to finish was just under 2 hours.

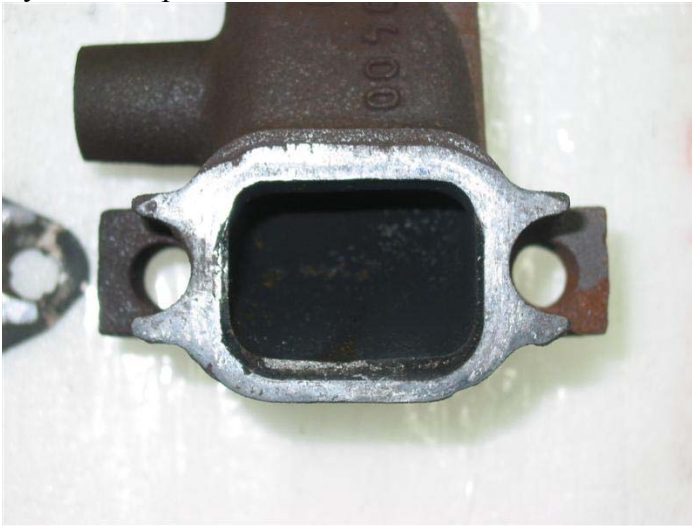
Here are few extra pictures to show how far the old manifold had shrunk, certainly this has not help the power output of the engine but I don't expect a real noticeable gain either. It might help the fuel economy a bit thou.

Cylinder #1 port mismatch:

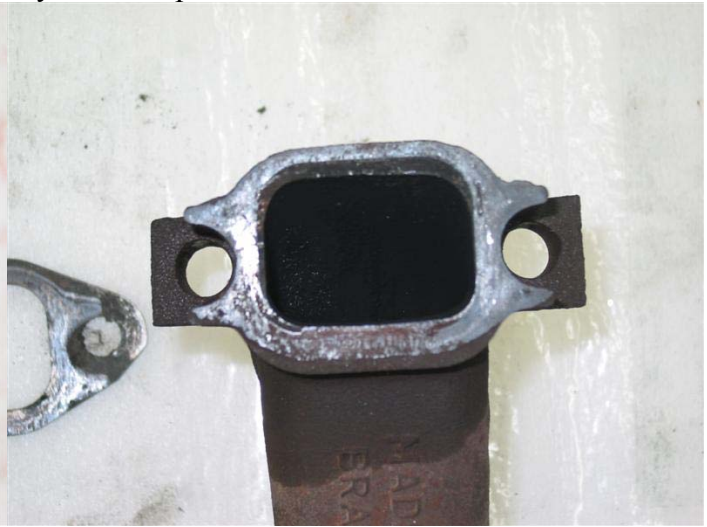
Cylinder #6 port mismatch:

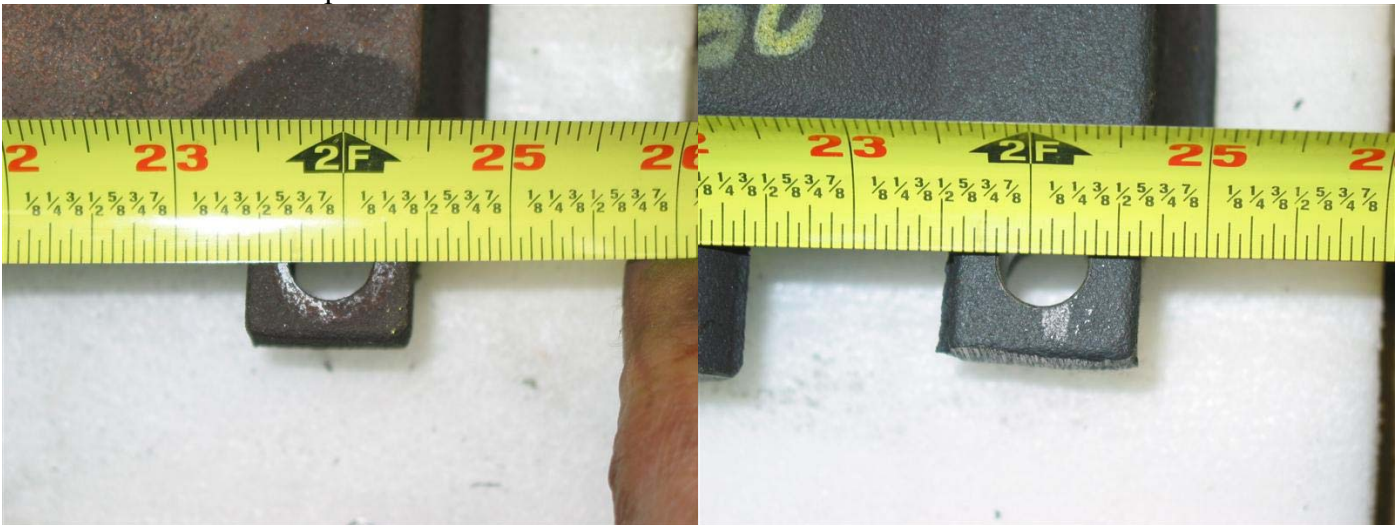
End to end bolt hole comparison of old manifold to new manifold:

New manifold is almost 1/4 inch longer then the old one.

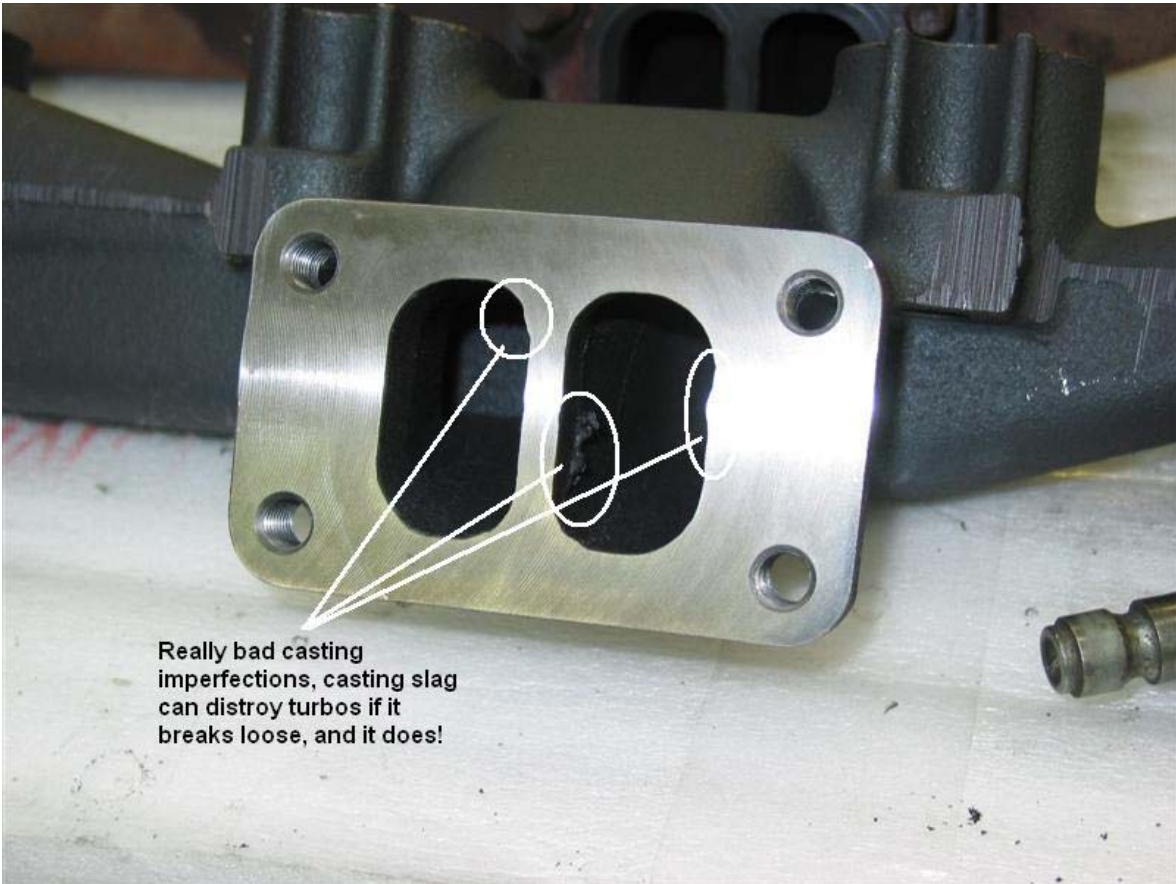
While inspection the new manifold I saw a lot of casting slag right at the mouth that feeds the turbo, this is NOT good. There are many reports of this casting slag breaking off and being ingested into the turbo which will result in a catastrophic failure of the turbo. The walls of the casting were a lot rougher then I thought was good so I decided to “port” the casting a bit to remove all accessible casting slag and smooth things up a bit. Short of sending this out for “extrudehone” it is the best that I could do with my porting tools. I was very surprised at the poor quality of the manifold as received!

Really bad casting imperfections, casting slag can distroy turbos if it breaks loose, and it does!
